APEX
509

SUMMARY REPORT OF HTRE NO. 3
NUCLEAR EXCURSION

GENERAL ⊛ ELECTRIC
ATOMIC PRODUCTS DIVISION
AIRCRAFT NUCLEAR PROPULSION DEPARTMENT

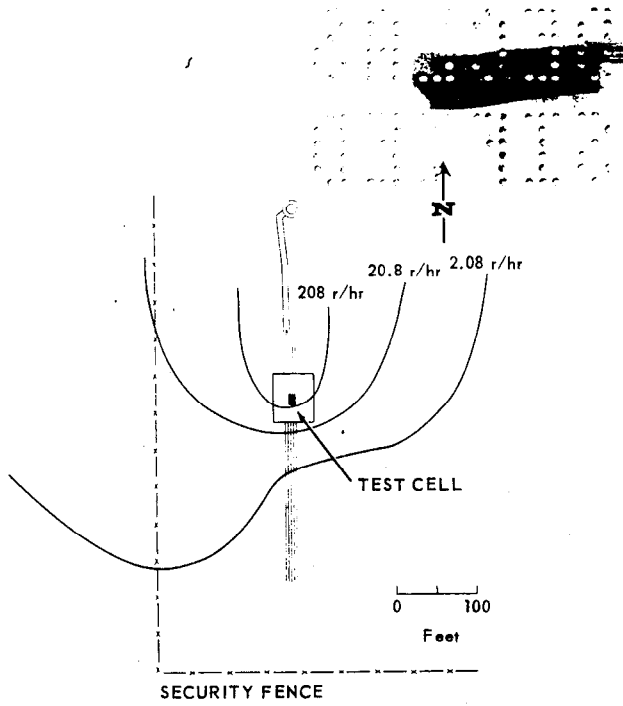
Fig. 42 – Gamma dose rate measurements corrected to 1 minute
after scram

The isodose plot for 1 minute. after scram was constructed by extrapolating the observed decay rates obtained with the portable survey instruments at time 4.7 hours and beyond back to time 1 hour, and then, by following the decay curve as observed by the test cell Jordan ion chamber from time 1 hour to 1 minute. The 62-hour isodose plot was measured directly using Geiger-Mueller and Cutie Pie instruments.

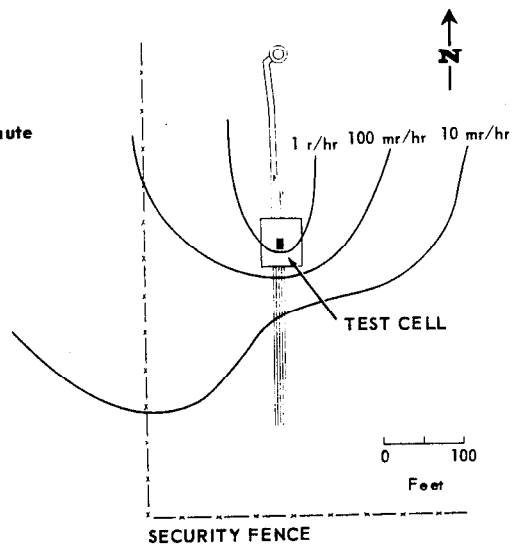
Fig. 43 – Isodose measurements 1 hour after scram

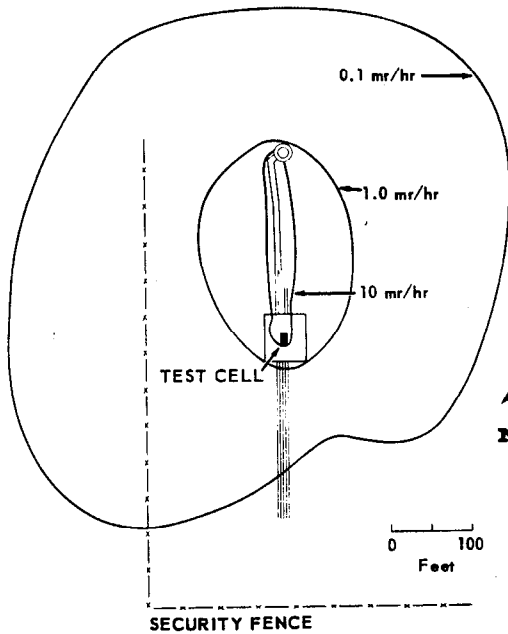
Fig. 44 – Gamma dose rate measurements 62 hours after scram

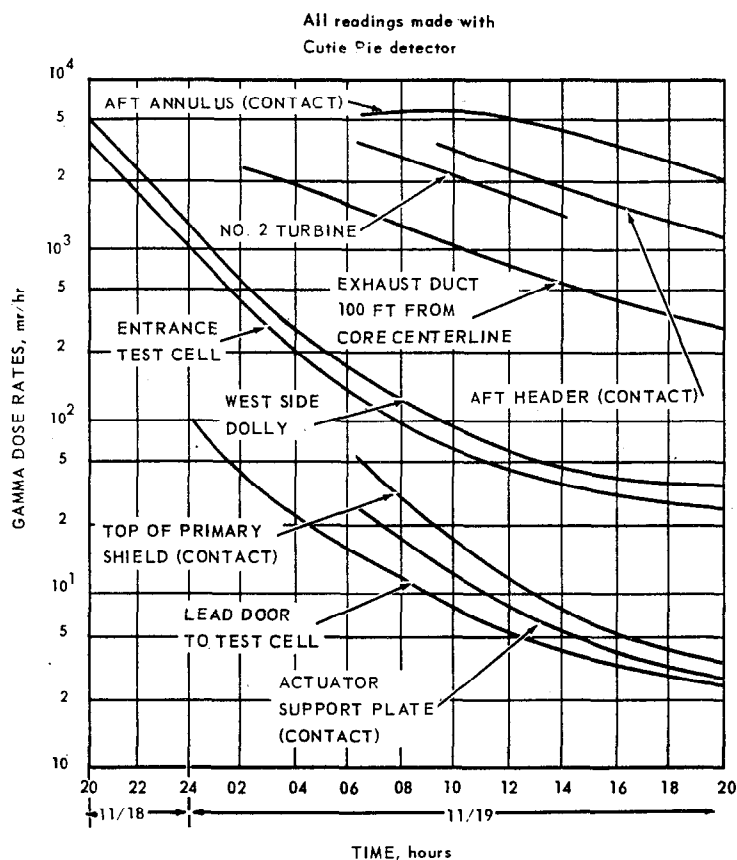
Radiation levels were measured with Cutie Pie meters at various points in and around the test cell including contact readings at several points on the D102A reactor assembly and on the IET large duct (approximately 100 feet from core centerline). Readings were repeated over a period of approximately 24 hours to follow the decay of the radiation levels. The resultant curves are shown in Figure 45. The highest radiation levels indicated are about 5 roentgens per hour, which tend to substantiate the belief that large quantities of fuel did not leave the reactor core and deposit in the dolly ducting or the IET large duct.

Fig. 45 — Radiation levels in test cell

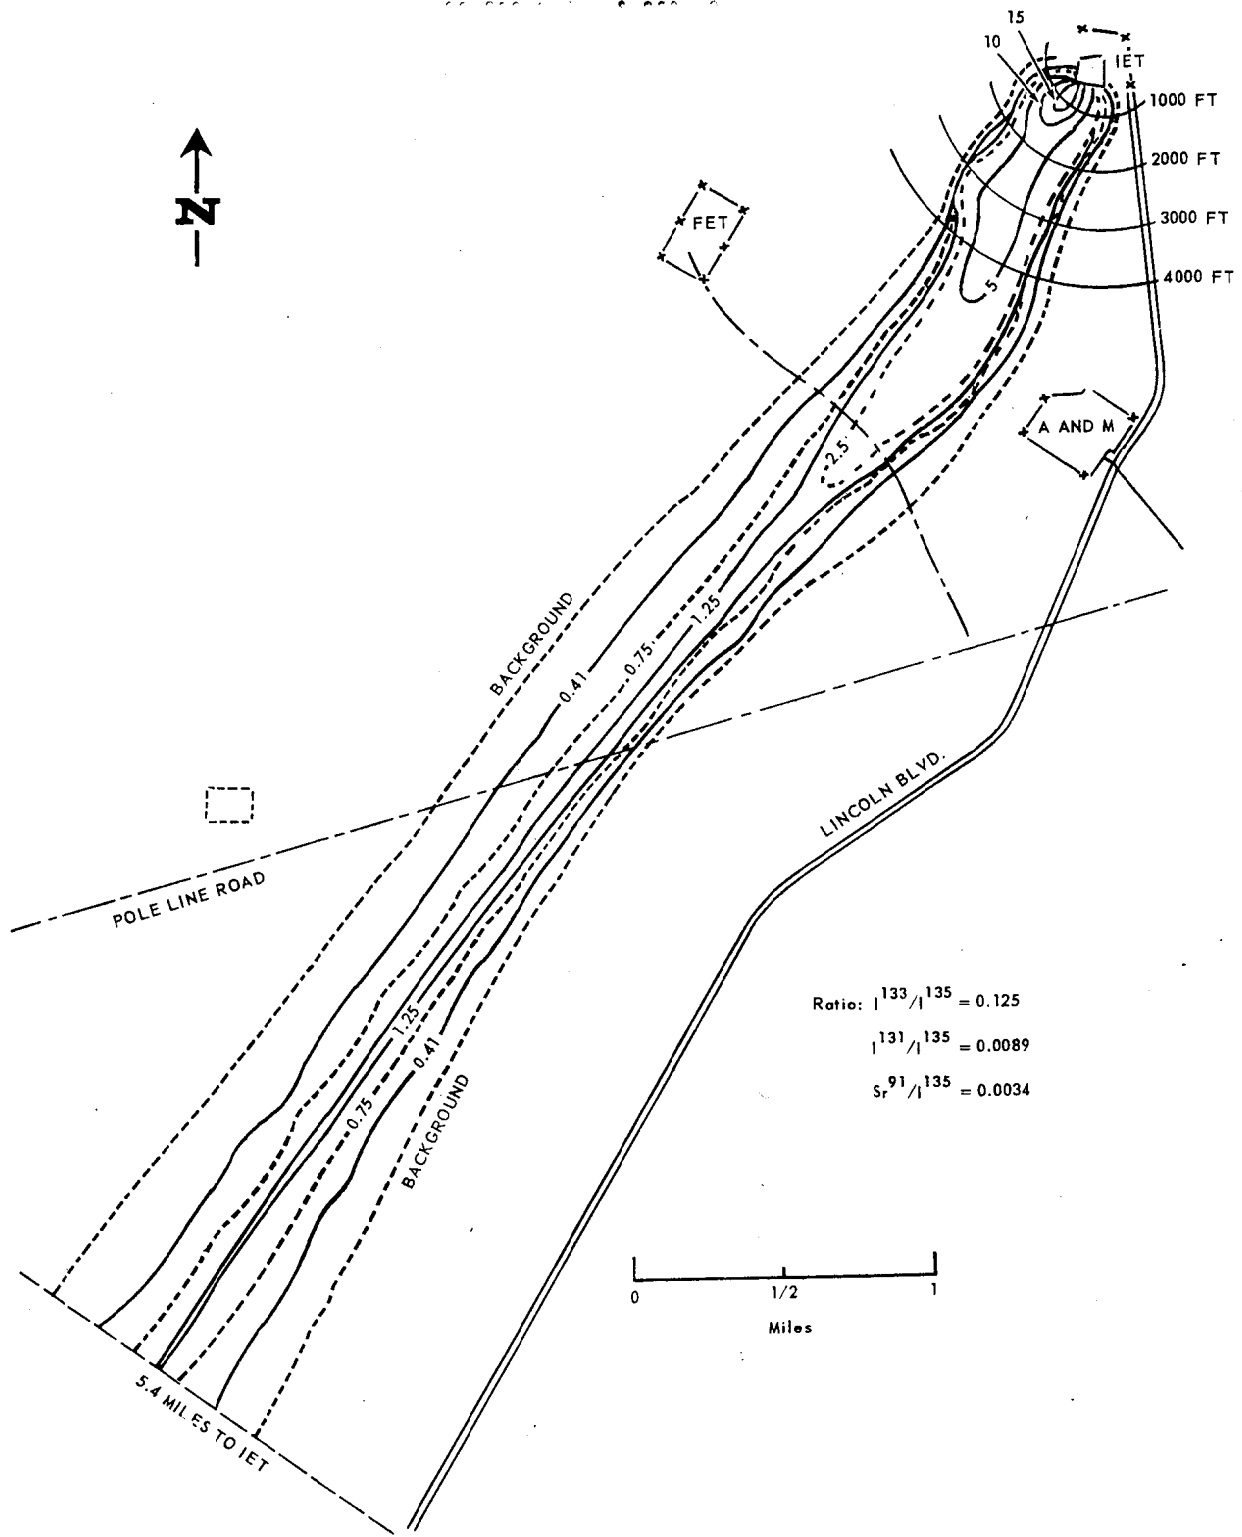
Fig. 46 —Isopleths of I^{135} activity at test site corrected to 2022

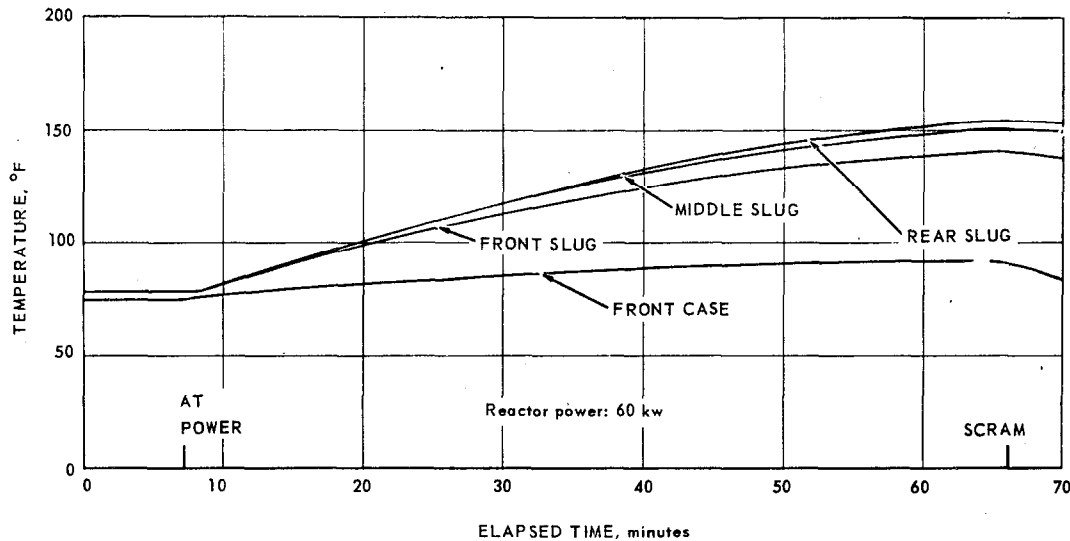
During the previous run (run 15-2) when reactor power was at about 0.060 megawatt,
the hydrided zirconium slugs in the heat sensor in control rod hole 520 showed a tem-
perature increase of about 0.030 degree per second during the first part of the run
when heat losses from the slugs were small (see Figure 50). The sensor therefore
measures reactor energy at the rate of 2.0 megawatt-seconds per °F when losses are
low. Extrapolation of data shows that during the power excursion, this same slug was
heated from about 130°F to at least 380°F, a difference of 250°F. The energy released
during the power excursion was, therefore, at least 2.0 megawatt-seconds per °F x 250°,
or 500 megawatt-seconds.

For this calculation the temperature of the slug before the excursion was assumed
to be the same as the inlet air temperature, which was measured 6 minutes after shutdown
and found to be about 130°F. However, the inlet air temperature during previous runs
at the same flow rate was about 80°F. If this temperature were applied to the calcula-
tion, the energy release determined would be at least 600 megawatt-seconds. Therefore,

Fig. 50 — Hydrided zirconium heat sensor temperatures, control rod hole 520,
run 15-2

this method showed reactor energy release to be at least 500 or 600 megawatt-seconds. This calculation agrees well with the 540 megawatt-seconds calculated from the appearance of the fuel, and also fairly well with the 765 megawatt-seconds obtained by indium foil exposure during the excursion.

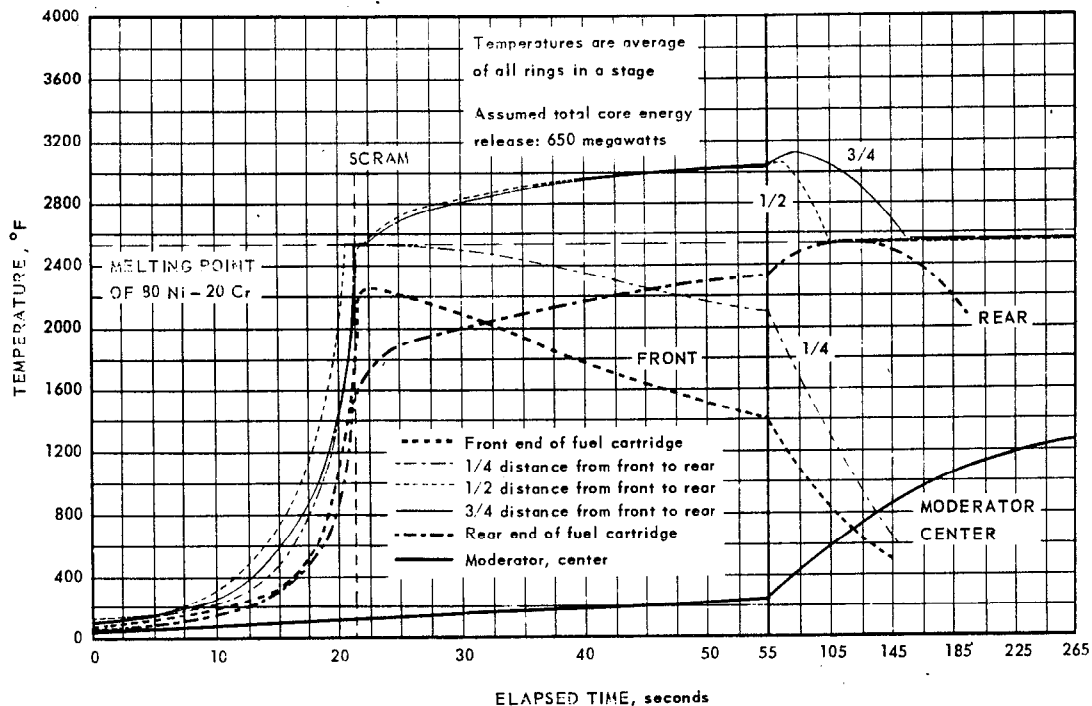
The results of this calculation are shown in Figure 51. The temperatures shown agree very well with reports of the physical damage and appearance of the core. They also agree with the temperatures observed during the event and those recorded 4 minutes after shutdown. The calculations show complete melting of fuel elements near the center of the core longitudinally, partial melting of fuel elements at the rear end of the core, and no melting at the front end. The longitudinal hottest portion of the inner moderator hexagons, about three-quarters of the distance from front to rear of the core, was calculated to reach 1200°F after 3 minutes and then to cool slowly. This calculation agrees qualita-

Fig. 51 — Calculated core temperatures caused by power excursion

Figure 51 summarizes most of the available information on which to base conclusions regarding the mechanism of shutdown of the excursion. It should be remembered that the calculation portrayed in this figure is based on the total power in a stage and the total heat capacity. It therefore represents the behavior of an average ring more nearly than that of a high-power ring. The average ring is ring 9, and the 12th ring, which is the highest power density ring, produces about 30 percent more heat per mass of ring than the average ring. At the assumed time of scram the average ring in the rear of the reactor had reached about 1600°F. This seems to be enough to assure that the outside ring, on which the scram thermocouples were mounted, had reached temperatures well above the scram settings. However, the unusual construction of this thermocouple, which is not attached directly to the fuel sheet, being shielded from the airstream with a small cap, makes it likely that the junction temperature can lag the plate temperature by several hundred degrees in a transient of this sort. Also, at the initiation of scram the central regions of the reactor had already started to melt. Figure 51 shows that the melting time for the average ring was about 2 seconds in the very center of the reactor. Since the witnesses reported that temperatures of 3000°F were indicated by the temperature instrumentation in the control room, it is possible that these temperatures were produced by melting of the thermocouple lead wires and the formation of new junctions in the central regions of the reactor, especially since the calculation shows that the rear of the reactor did not reach this temperature. Depending on the configuration of the melting it is possible that these junctions could have formed very near the time of scram. Therefore, it seems impossible to say whether the scram signal was produced by the actual thermocouple junction or by open circuit indications or by the formation of new thermocouples in the center of the reactor. In addition, the figure shows that at or very near the time of scram, collapse of the fuel elements had started. The total amount of reactivity reduction produced by this collapse was 2.13 percent. This is slightly greater than that carried in the scram rods. Therefore, it appears that collapse of fuel rings contributed substantially to the shutdown mechanism, although the 2.13 percent produced in this manner could not have been introduced instantaneously. The actual rate of introduction of this loss of reactivity is indeterminate, and the total energy released is sensitive to the rate of introduction of negative reactivity.

Regardless of the precision of the numbers it appears reasonable to conclude that the excursion proceeded about as indicated in Figure 51. The strongest evidence that supports the total energy release is the appearance of the fuel cartridges confirmed by the calculation reported in the first paragraph of this section and summarized in Table 8. The single discrepancy lies in the fact that the moderator heat sensor data, although consistent from run to run, indicates much too large a fraction of total energy deposited in the moderator. This indication remains an anomoly at the time of this writing, although it will be the subject of further investigation.

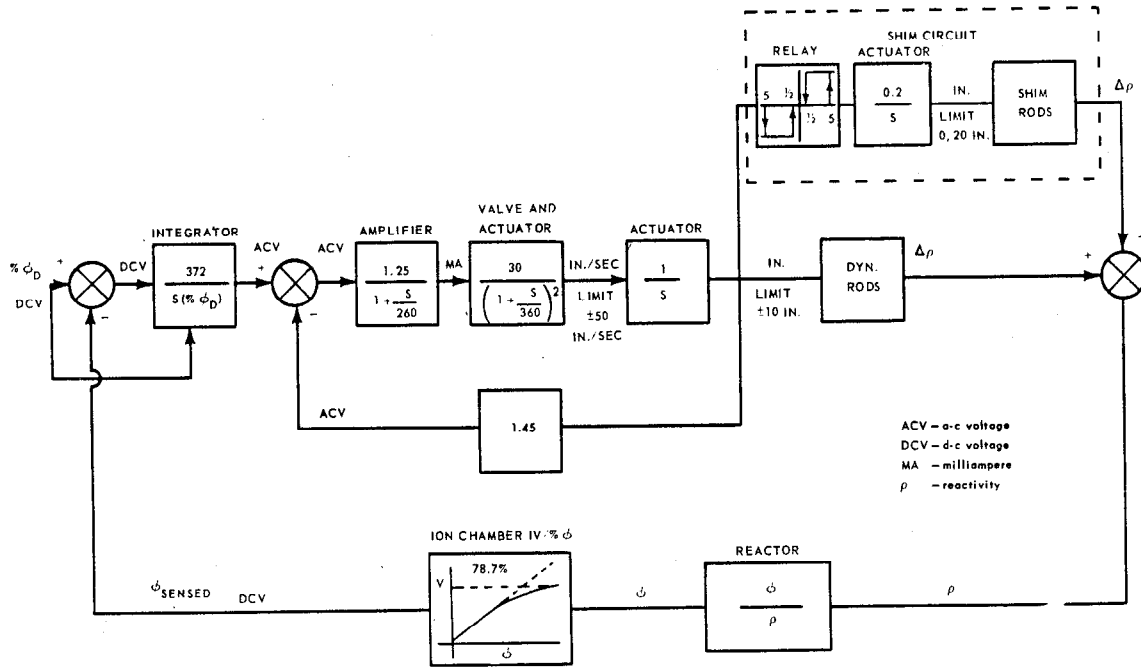
The reactor power-range control, shown in Figure 52, was represented by a complete nonlinear simulation including velocity and rod position limits, reactivity nonlinearities in the dynamic and shim rods, and the variable gain integrator in the forward loop.

Fig. 52 – Reactor power-range control circuitry

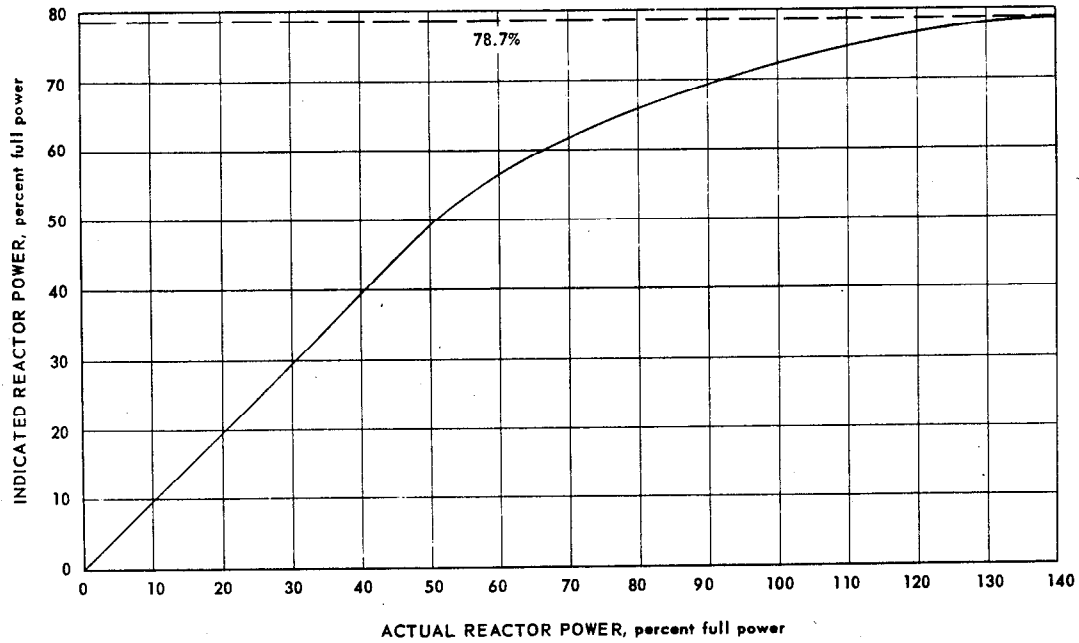
The ion-chamber feedback was estimated to saturate in the manner shown in Figure 53. These data were obtained through extrapolation of previously derived curves in combination with ion-chamber power supply and sensing circuit load characteristics.

Fig. 53 – Calculated ion chamber saturation

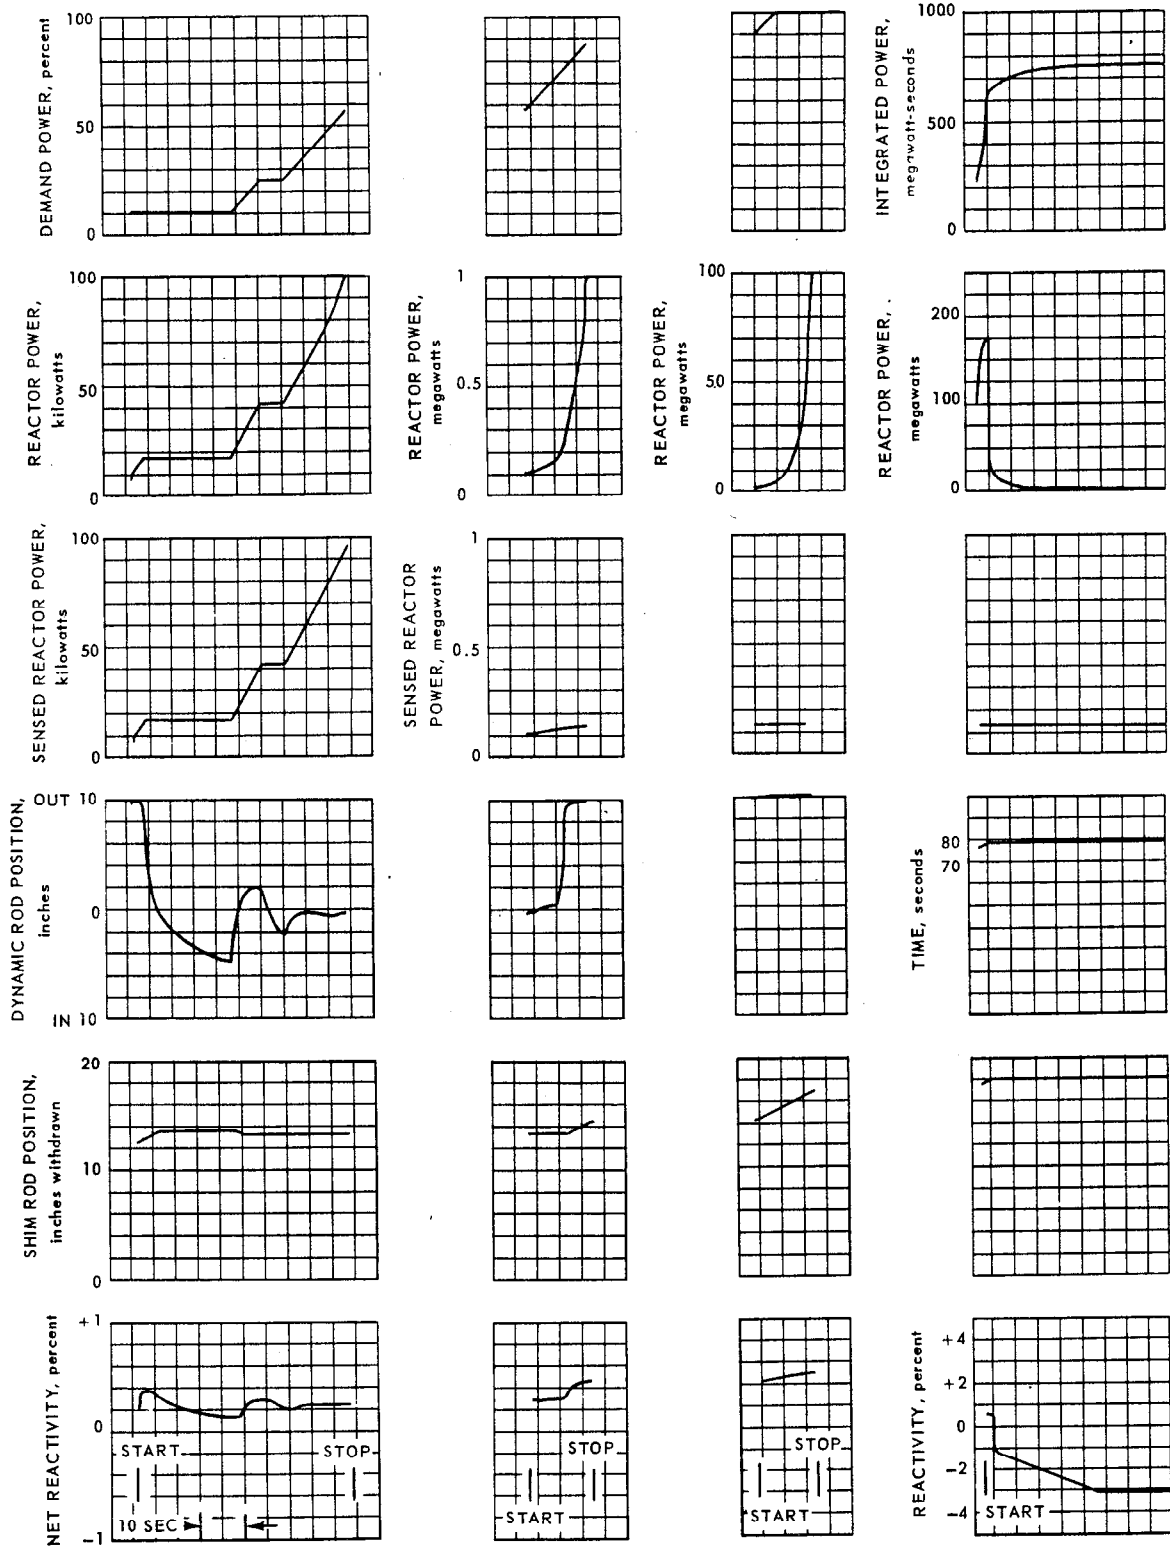
The total time to scram was slightly (0.3 second) longer for the dynamic rod insertion of 9.5 inches at transfer than it was for the 10.5-inch insertion.

Fig. 56 — Computer traces of transient with dynamic rods 10.5 inches inserted

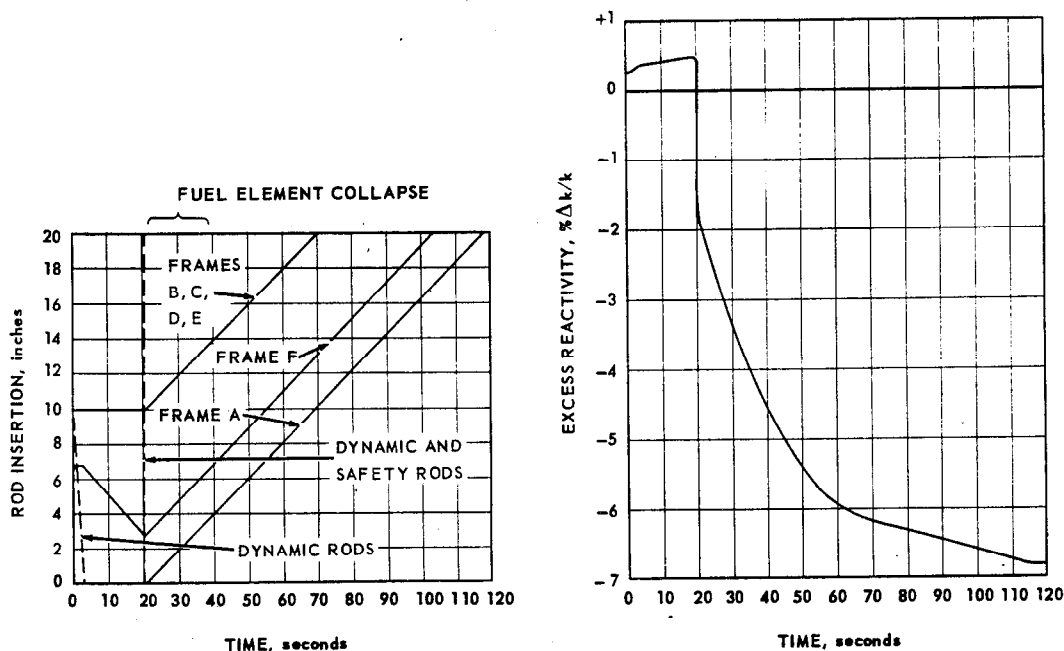
Fig. 57 – Rod motion and excess reactivity versus time

Power Comparison - Figure 57 diagrams the rod motion and resulting reactivity outlined in the sequence; Figure 58 compares the calculated power with the linear-flux trace. The total integrated energy for the analytic excursion was 590 megawatt-seconds as compared to a foil-measured value of 760 megawatt-seconds.

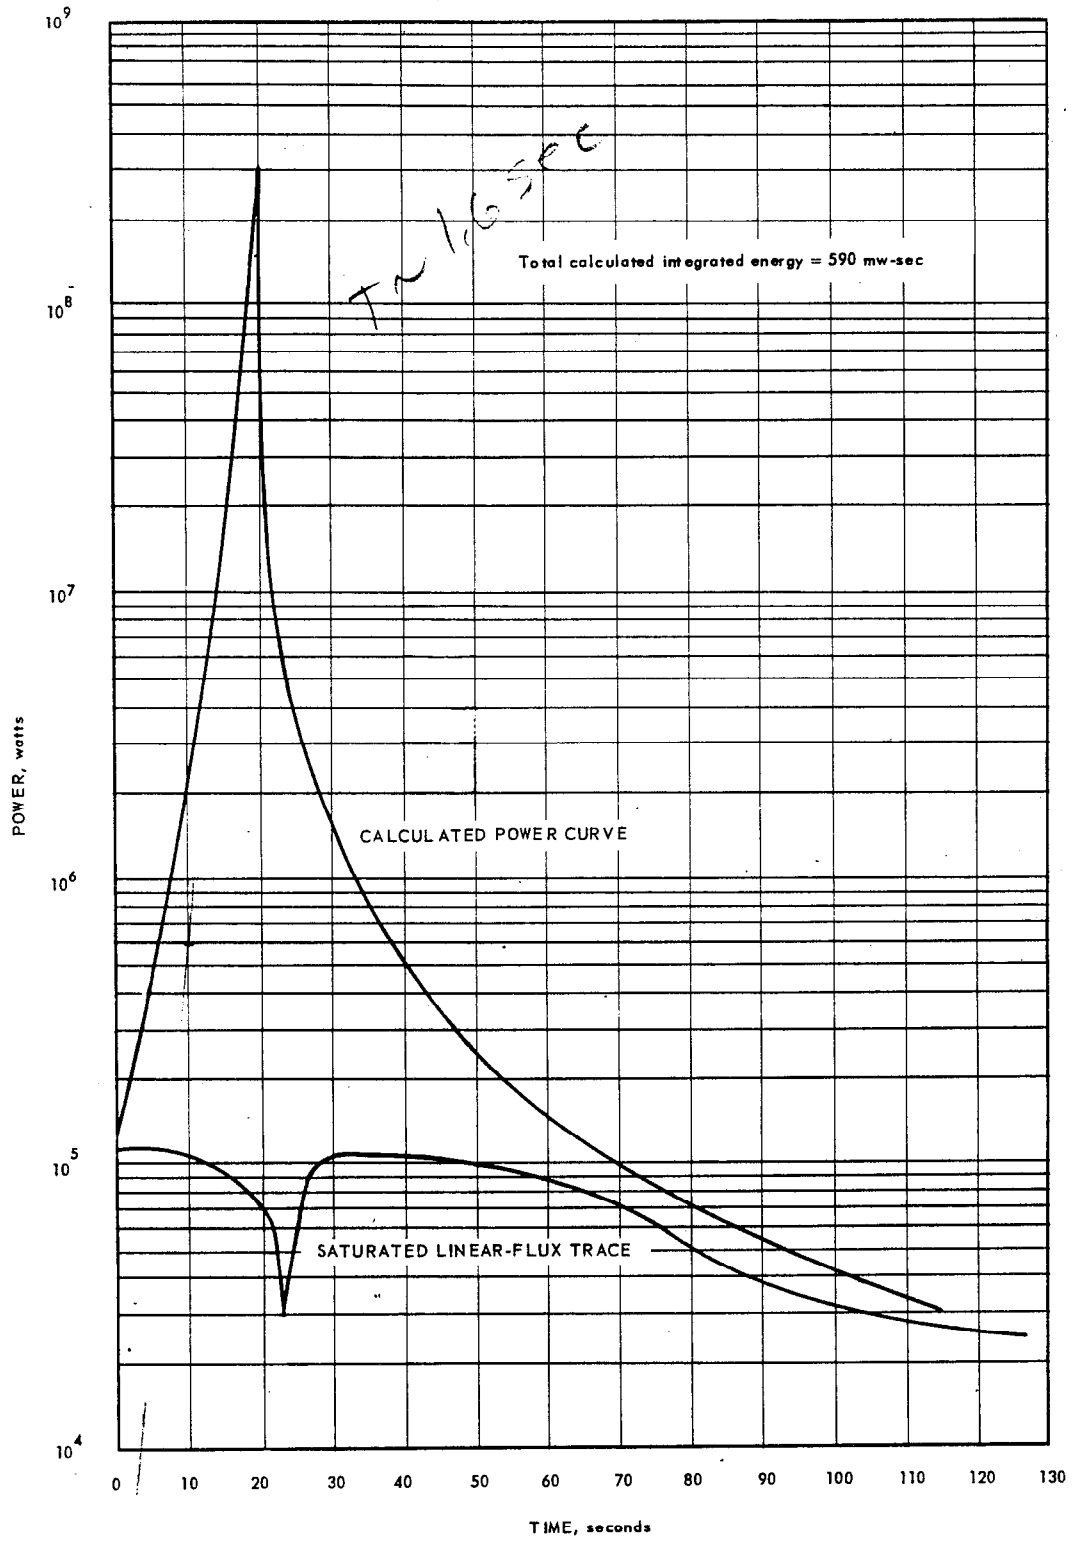
Fig. 58 — Comparison of calculated power with observed linear-flux trace assuming
a negative linear change of 2 percent $\Delta k/k$ in 20 seconds

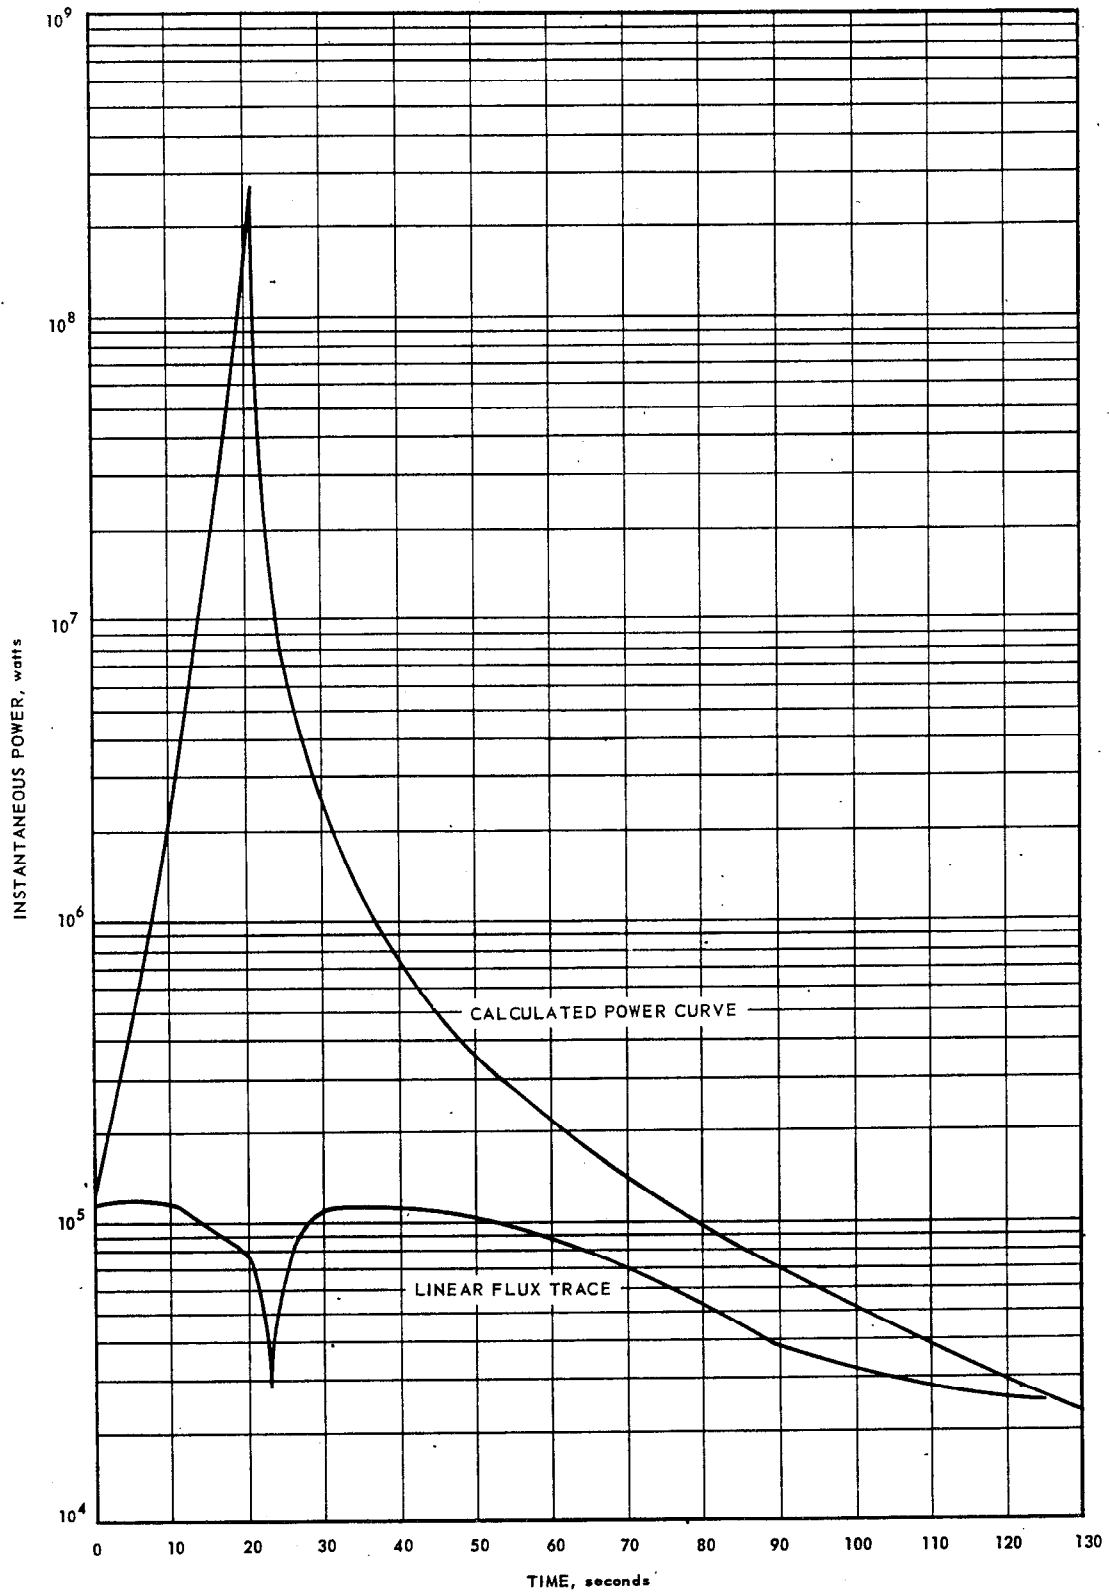
Fuel Element Collapse Rate - Similar calculations were made for a change in the fuel element collapse rate to 2 percent $\Delta k/k$ in 49.61 seconds. The effect of this change was to increase the peak power reached to 280.49 megawatts and the total energy release to approximately 650 megawatt-seconds. The results of this calculation, shown in Figure 59, were used as input to the temperature calculation depicted in Figure 51. Use of the shorter fuel element collapse time improves the correlation of the linear-flux trace and the calculated power near the end of the excursion. Reducing the fuel element collapse time to less than 20 seconds would probably improve this comparison, however, the total energy would be reduced still further. In addition, equal power points as shown on the linear-flux trace before and after the excursion do not necessarily correspond to equal power levels. The reason is that the delayed fission product gammas produce an increase in the gamma-to-neutron ratio following the excursion. Consequently the saturation characteristics of the linear-flux instrumentation are changed, in effect increasing the recovery time of the chamber.

Fig. 59 — Comparison of calculated power with observed linear-flux trace assuming
a negative linear change of 2 percent $\Delta k/k$ in 49.61 seconds

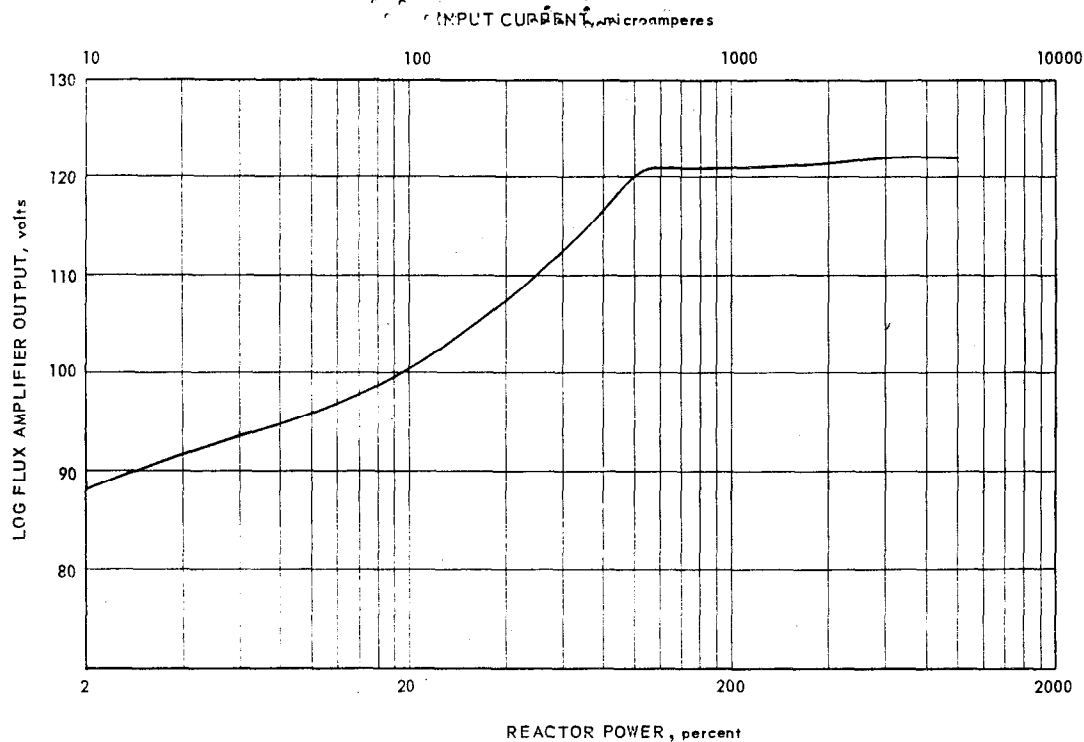
The log-flux amplifier is not normally used during power-range operation. The amplifier is so designed that the log diode characteristic becomes linear above 20 to 30 percent of full power, depending on the individual diode. A typical characteristic curve showing the upper portion of the log-flux amplifier response is shown in Figure 60. During the operation of this amplifier in this region of linear response, the period signal response indicates a shorter period than the actual period of the reactor. For this reason, the period-amplifier safety circuits are normally automatically bypassed during the power-range operation. Complete saturation of the log-flux amplifier occurs at an input current between 500 microamperes and 1 milliampere, depending upon the particular log-flux amplifier board checked. This represents a flux level of approximately 100 to 200 percent.

Fig. 60 — Typical log-flux response, upper portion

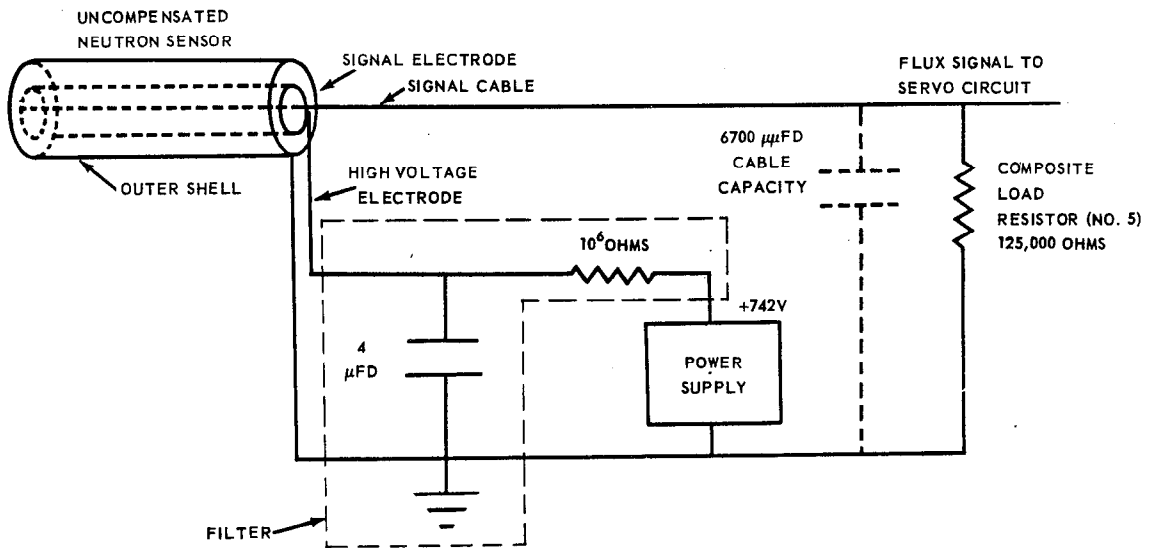
Fig. 62 — Neutron sensor and portion of linear-flux channel

on Figure 62.) The outer surface of the inner electrode and the inner surface of the middle electrode are coated with boron, thus making the chamber neutron sensitive. The signal current is normally derived from the inner electrode and the chamber collecting voltage is normally applied between the middle electrode and ground. The signal electrode is connected to ground through a 125,000-ohm signal voltage developing resistor. The outer electrode or housing is connected directly to ground and prevents an electrical shock hazard, facilitates chamber mounting within the reactor, and provides extrinsic electrostatic shielding of the signal electrode. There was approximately 0.0007 microfarad of cable capacity across the signal-developing resistor; the chamber collecting voltage was obtained through an RC filter from a variable voltage power supply that was set for an output voltage of 800 volts. (The design setting for the power supply was 1500 volts.) The actual voltage out of the power supply however, was 742 volts. The power-supply filter, which was not a part of the circuit as designed, consisted of a 1-megohm resistor electrically connected between the power supply and the high-voltage electrode in the ionization chamber and a 4-microfarad condenser, which is electrically connected across the chamber high-voltage electrode and ground. Figure 63 shows a photograph of the RC filter and its location with respect to the linear-flux and log-flux power supplies in the IET control console. This filter was originally used with the HTRE No. 1 (compensated ion chamber) linear flux circuits to eliminate difficulties due to power-supply noise being coupled from the high-voltage electrode to the signal electrode by means of the chamber interelectrode capacity. The filters were permanently mounted in a separate drawer in the IET secondary relay panels and were connected into the circuit by means of coaxial cables. Figure 64 shows the characteristic curves of a prototype ionization chamber.

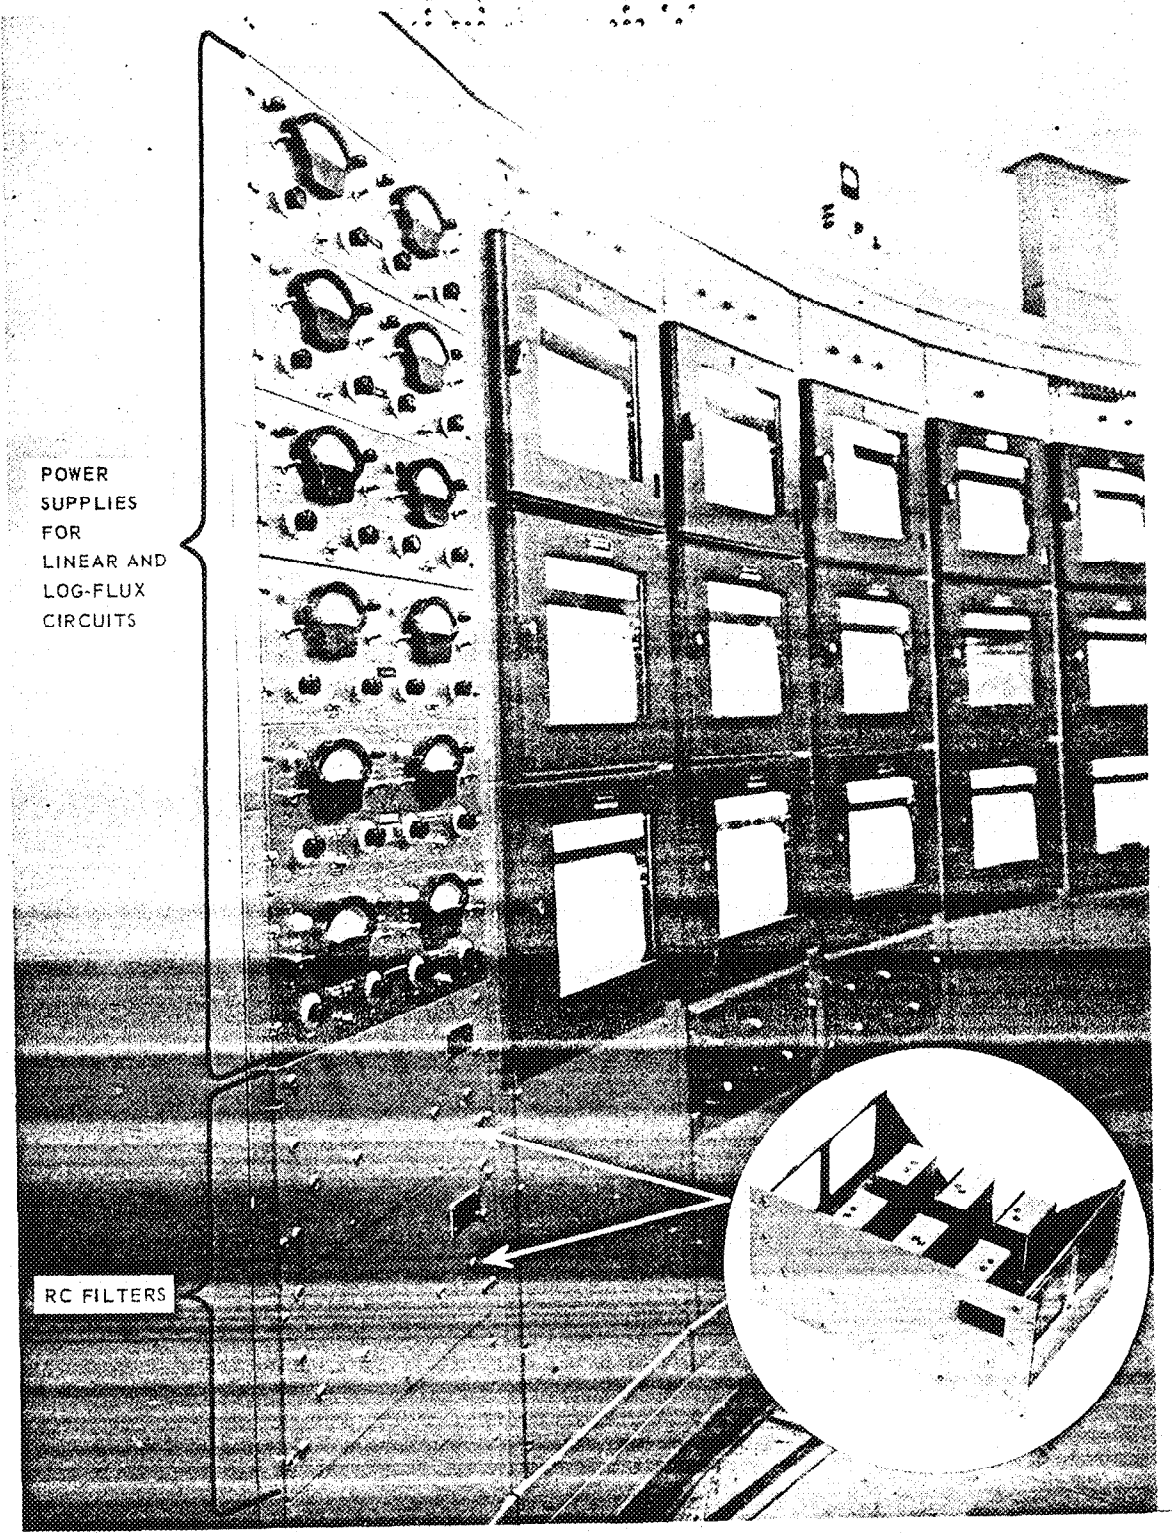
It can be concluded that the primary cause of the incident was that the linear-flux circuitry was unable to indicate true reactor power because of the presence of electrical noise filters in the circuitry. In addition the power supply was set at 800 volts. The recommended setting for these power supplies when the circuitry was designed was 1500 volts. Had the power supply been set at 1500 volts the flux level at which saturation occurred would have been increased. For this particular run this increase might have been sufficient to permit the indicated flux signal to satisfy the demand. Thus it is seen that the physical cause of the incident was the presence of two conditions, the removal of either of which might have prevented the incident. These two conditions can be attributed to human factors and not to basic design of the reactor or of the instrumentation.

Fig. 63 — IET control console showing location of RC filter

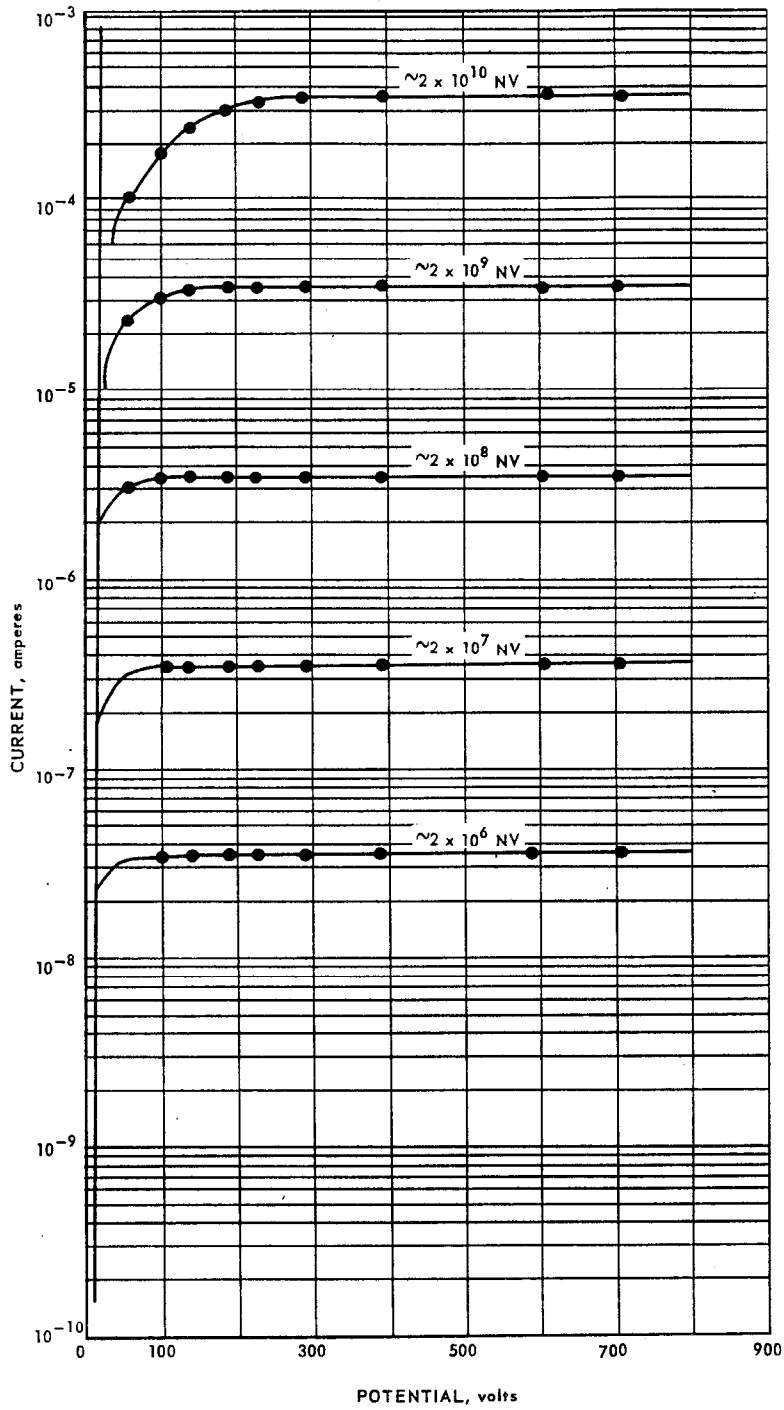
By examination of Figures 64 and 65 it is possible to determine why the linear-flux-channel signal could not satisfy the signal demand of the servo system. The 80 percent demand setting required a signal current of 0.65 milliampere. If the ionization chamber were operating in a voltage-saturated condition, that is, on the flat part of its characteristic curves, as it should, the thermal neutron flux level as seen by the chamber would be approximately 5×10^{10} nv. The curves show that to collect this amount of current properly a minimum of 300 volts must exist across the chamber electrodes. However, if 0.65 milliampere flows through the 1-megohm filter resistor, it must cause a voltage drop of 650 volts. In addition, the voltage drop across the signal-developing resistor must be approximately 80 volts. Thus if this condition were possible, only 20 volts would remain to act as the ionization chamber collecting potential, considerably less than the 300 volts required for proper operation.

Fig. 64—Output current as a function of applied potential, prototype uncompensated
ion chamber

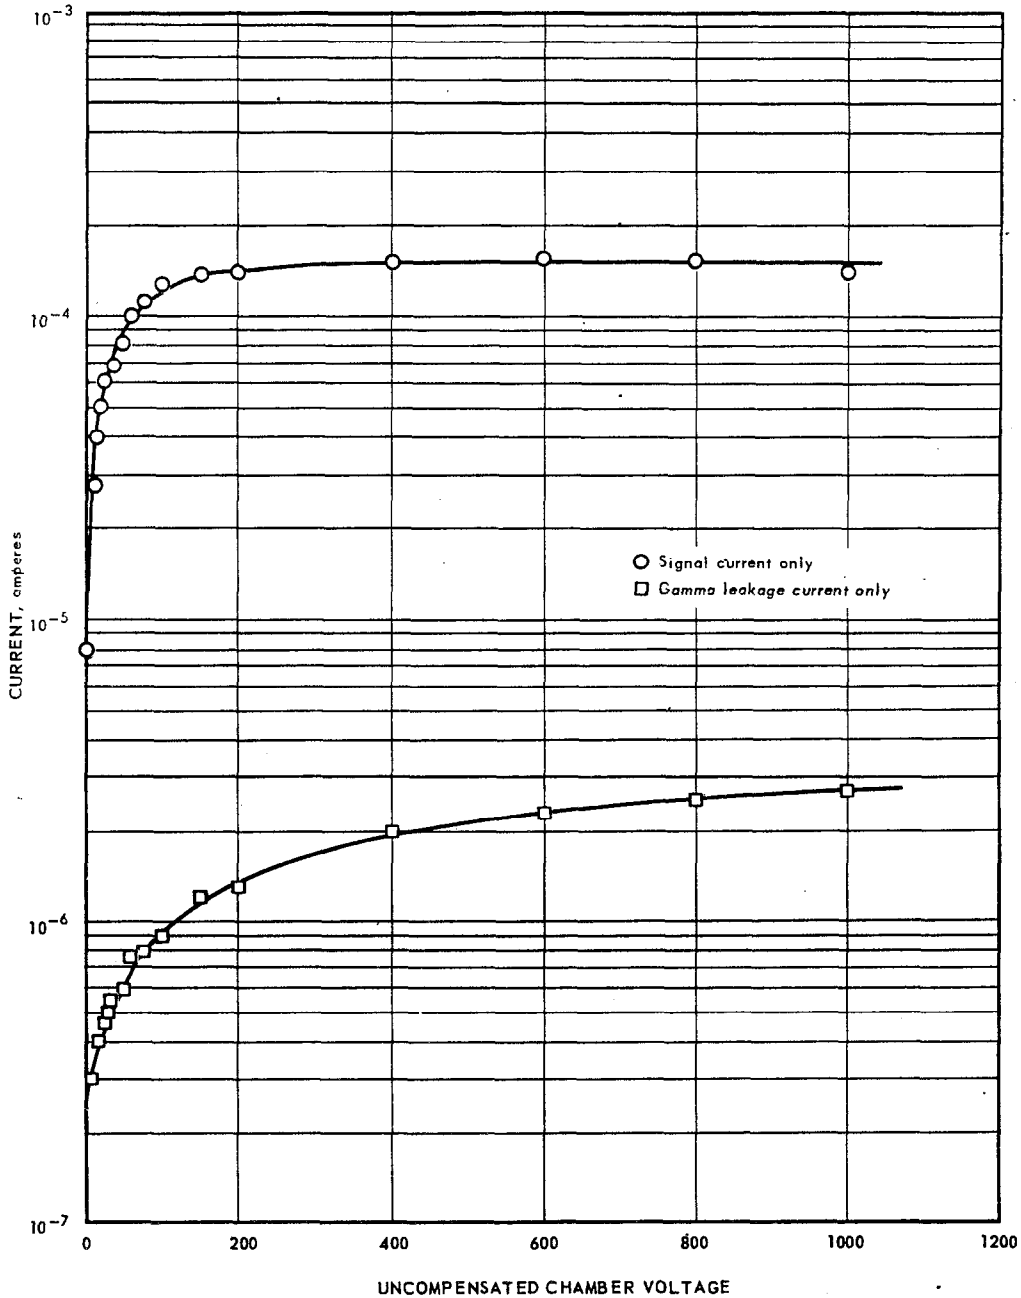
One of the uncompensated ion chambers in use during the excursion was tested in the MTR to determine the amount of gamma leakage current and to reaffirm the chamber characteristics. The curves thus obtained are shown in Figure 66. The curve of current versus collection voltage shows that the chamber behavior was very close to that of the prototype, the characteristics of which were used to construct the hypothesis regarding behavior of the chamber. The gamma leakage current is about as expected and is such that the current bypass produced by the gamma leakage can be expected to begin driving the circuit downscale at fluxes or power levels roughly 100 times greater than those at which the circuit becomes current limited. Based on the characteristics of signal current

Fig. 66 — Uncompensated ion chamber characteristics derived from MTR test, reactor at 40 kilowatts (2.88 x 10^9 nv)
