APEX
509

SUMMARY REPORT OF HTRE NO. 3
NUCLEAR EXCURSION

GENERAL ⊛ ELECTRIC
ATOMIC PRODUCTS DIVISION
AIRCRAFT NUCLEAR PROPULSION DEPARTMENT

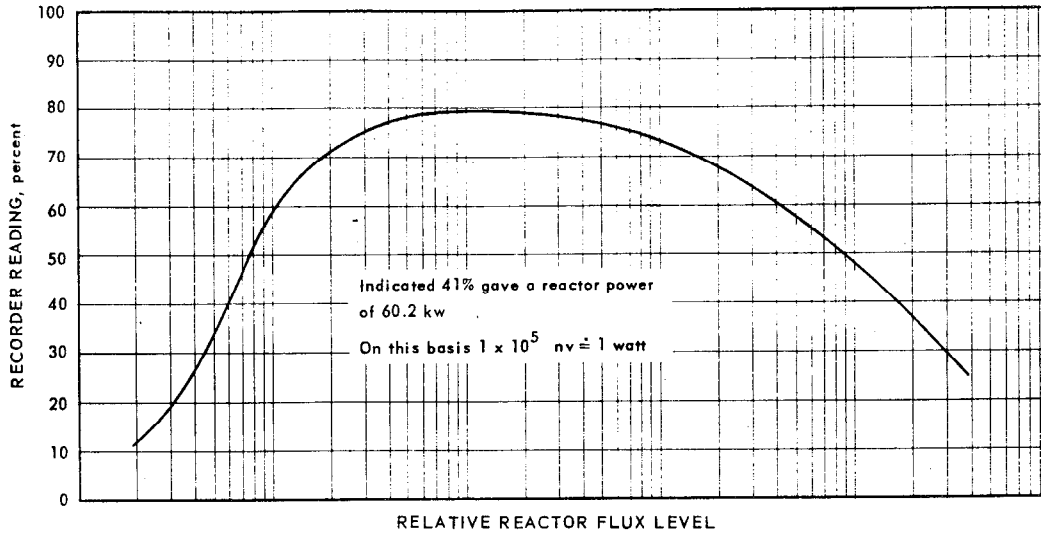
and gamma current shown in Figure 66, a circuit characteristic curve has been derived and is shown in Figure 67. This curve is calculated from the characteristics obtained in the MTR test and shows the expected linear-flux-circuit indication as a function of relative flux level.

Fig. 67 — Calculated linear-flux circuit characteristics based on MTR test

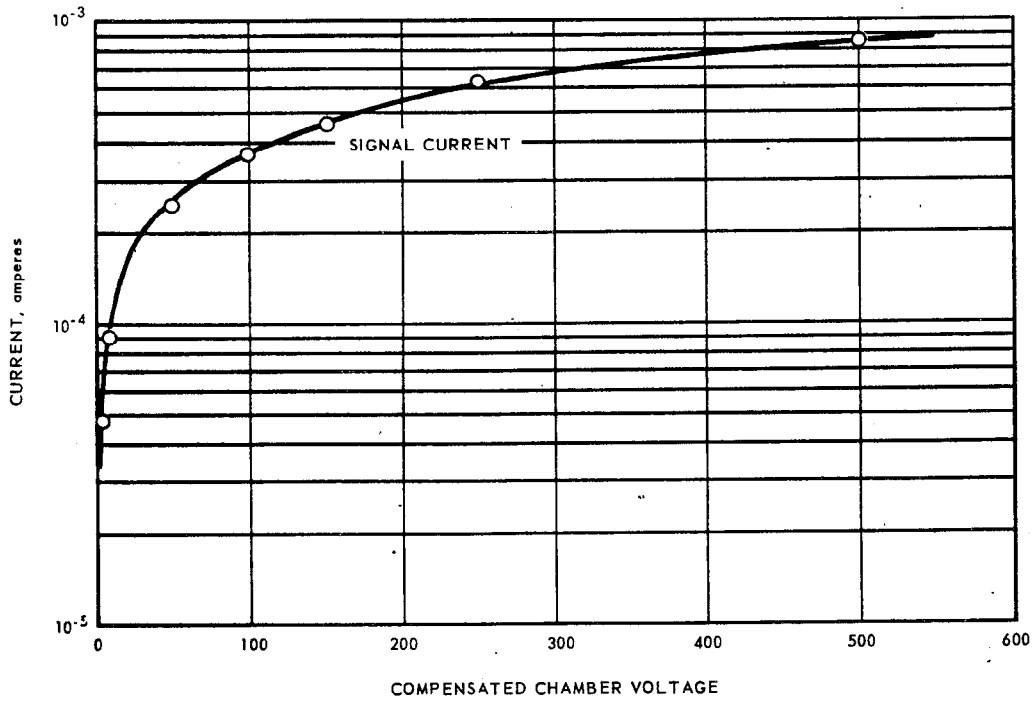
Fig. 68 — Compensated ion chamber characteristics derived from MTR test,
reactor at 400 kilowatts (2.64×10^{10} nv)

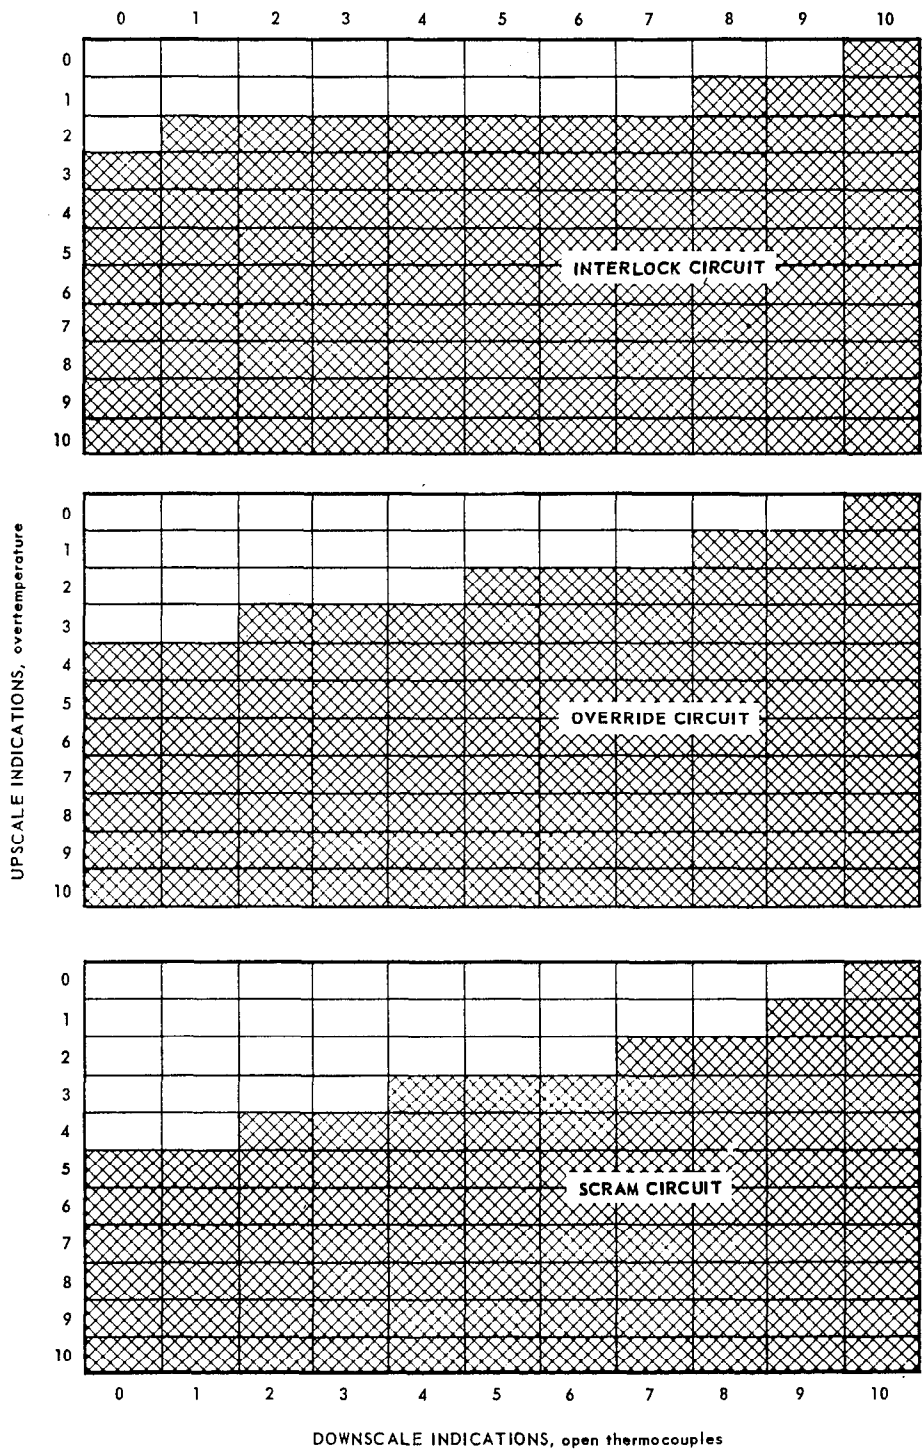
The fuel element temperature bridge was checked in Idaho after the excursion. Three upscale readings were found to be required for an interlock response, four for override, and five for scram. Potentiometers in series with each safety-level relay will change the number of thermocouples required to give a safety response by one or two thermocouples. The chart in Figure 69 shows the number of upscale readings (overtemperature) versus the number of thermocouples that are open (causing a downscale reading) required to give the various safety responses. The potentiometers of the bridge were adjusted to correspond to the number of upscale indications required at Idaho. This test was then carried out up to 10 open-couple responses in tests made at Evendale. Because of the settings of the recorders for normal power-range operation, the low airflow in the system, and the initial low-temperature operation, the fuel element temperature

Fig. 69 — Fuel element temperature bridge

circuit was slow to respond. The fuel element temperature circuit was credited with giving the initial scram action as observed by the operators. Ten thermocouple open circuits are required for a scram response in the absence of any upscale reading. Table 6 (page 70) shows the postexcursion condition of the ten thermocouples that were connected into the scram circuit.

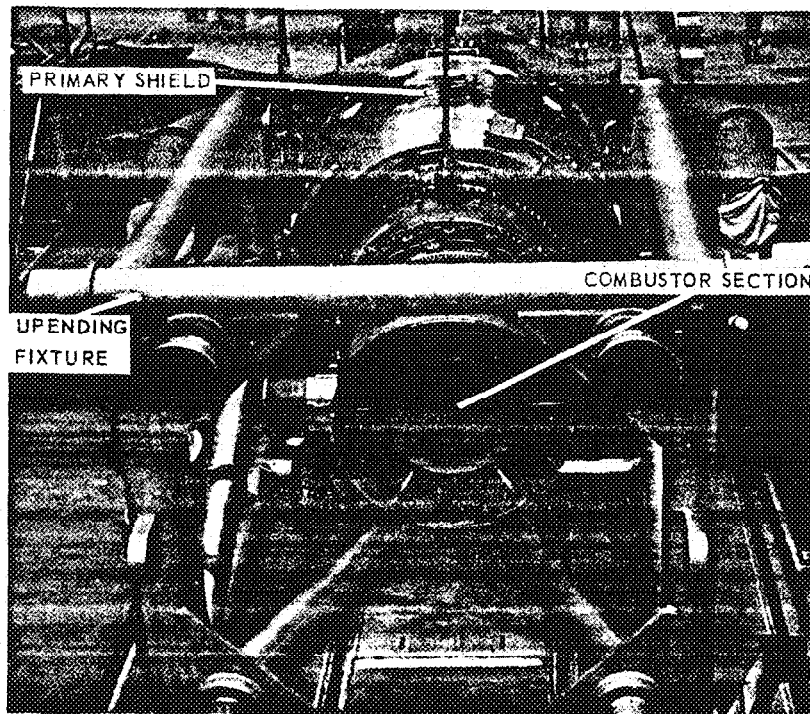
In the Hot Shop the nuclear sensing instruments were removed from the core and three BF_3 counters were placed on the side of the primary shield for monitoring the core during disassembly, as shown in Figure 70. The instrumentation cabling, pressure tubing, aft header, hot ducting, and cold ducting were removed from the dolly; the primary shield, front plug, core, rear plug, and combustor were lifted as a unit and placed in the upending fixture still in the horizontal position. This unit is shown in Figure 71.

Fig. 71 — Reactor-shield assembly in upending fixture

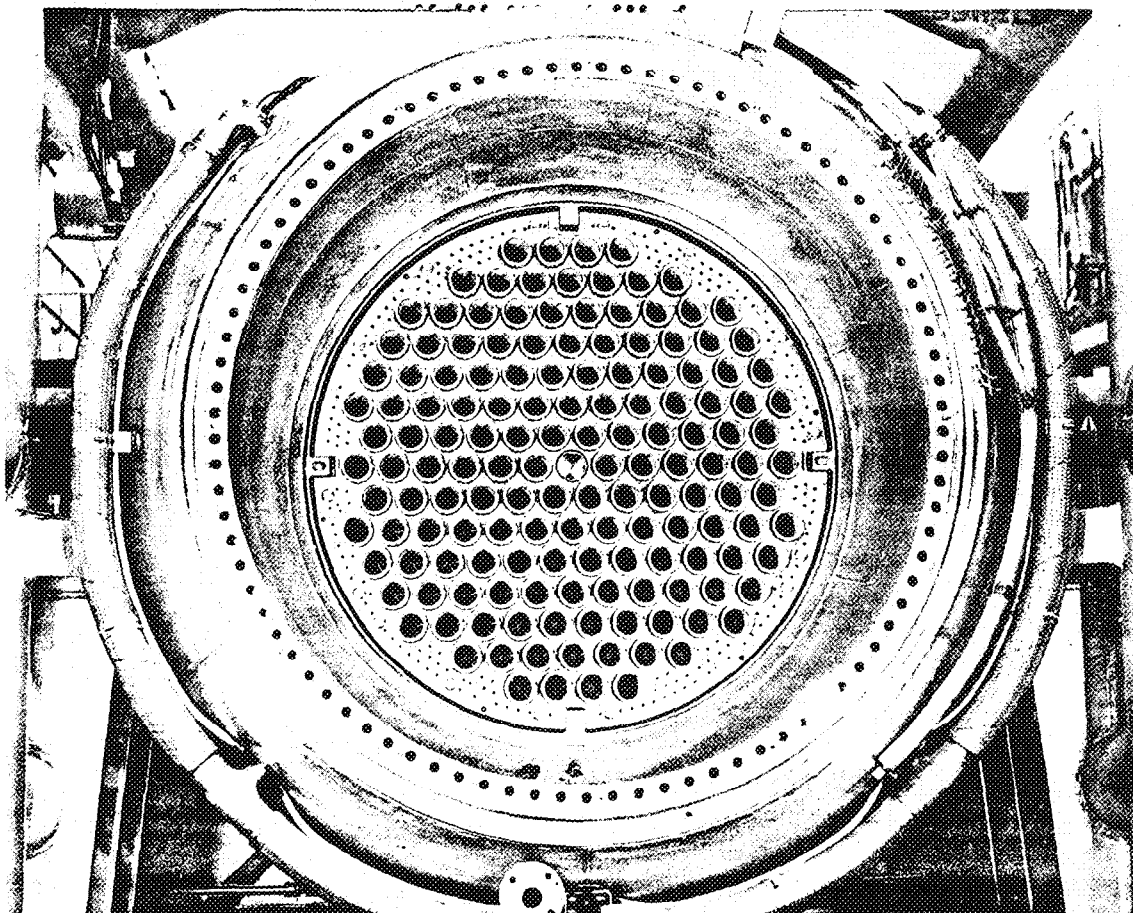
The combustor and rear plug were removed from the core and primary shield (while the unit was still in the horizontal position) in that order, exposing the rear tube sheet, shown in Figure 72. An attempt was then made to release all fuel cartridges by inserting a release rod through the center of each cartridge. It was impossible to insert the rod more than 3 or 4 stages into any of the cartridges because of the collapse of the fuel cartridge stages.

Fig. 72 — Rear tube sheet exposed after removal of combustor and rear plug

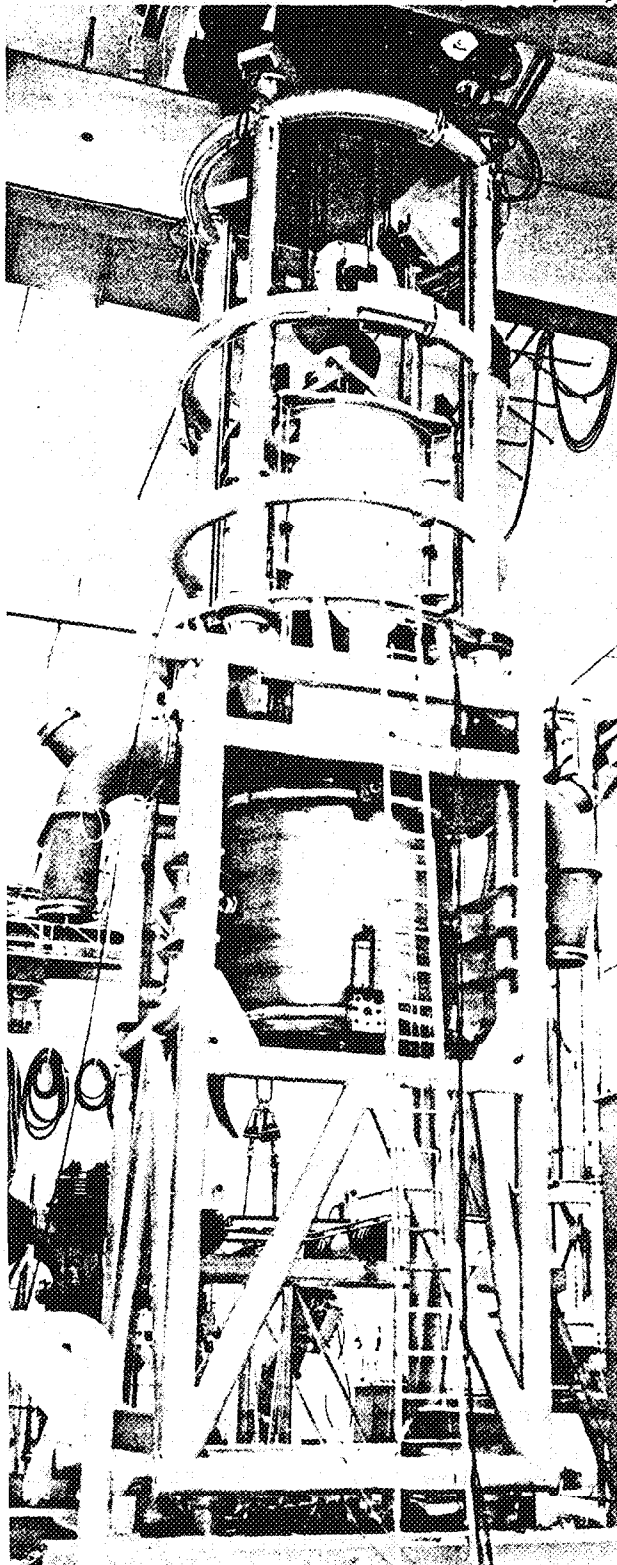
Fig. 73 — Upending fixture in vertical position with core-removal fixture on top

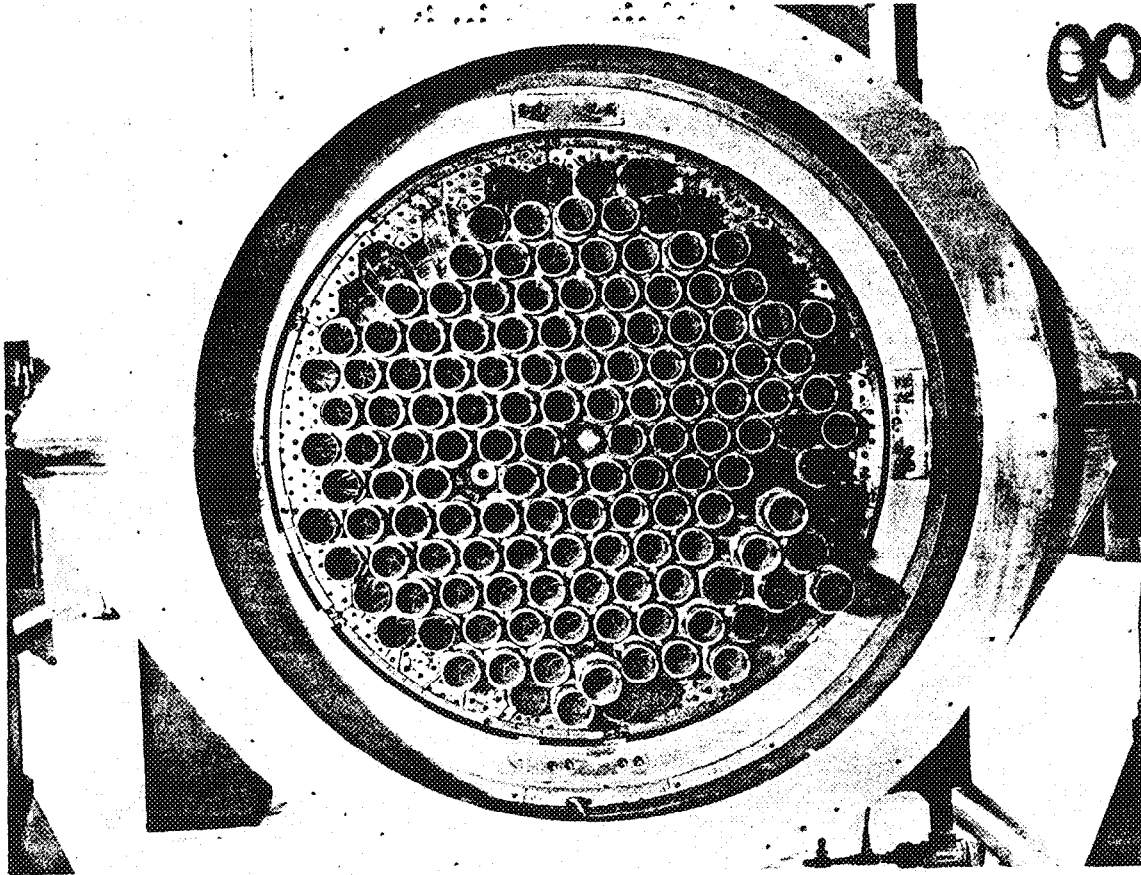
The rear tube sheet was removed from the core to expose the moderators, shown in Figure 74. The unlatched moderator cells were then removed from the core. The latched moderator cells with fuel were released by manually moving the latch fingers together with a suitable tool placed through the bellmouth assemblies on the front tube sheet. All but five moderator cells with fuel could then be removed from the core. The remaining five moderator cells were fused to the control rod guide tubes. The control rod guide tubes that were fused to the moderator were then cut off just upstream of the fused section.

Fig. 74 — Moderators exposed after removal of rear tube sheet

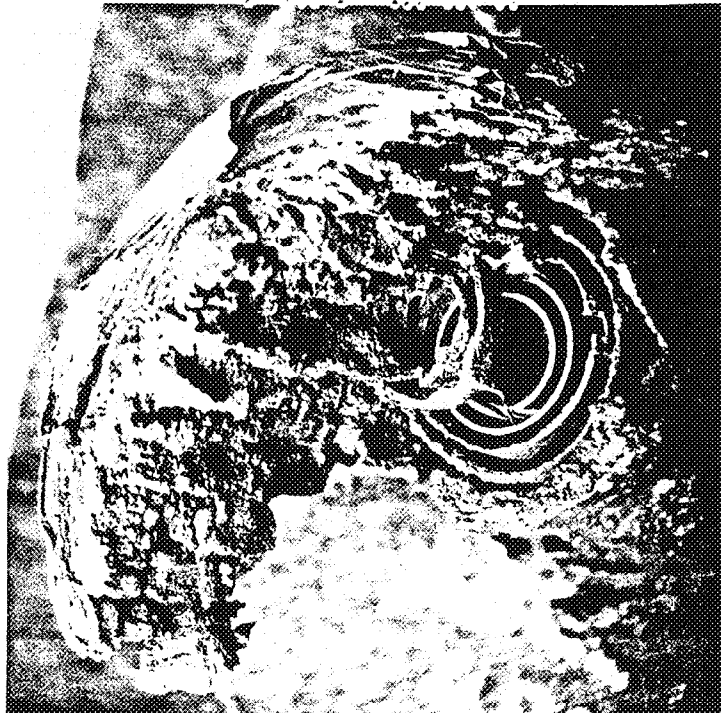
Fig. 78 — Meltdown and oxidation of stage 5, cartridge 1060, cell 273

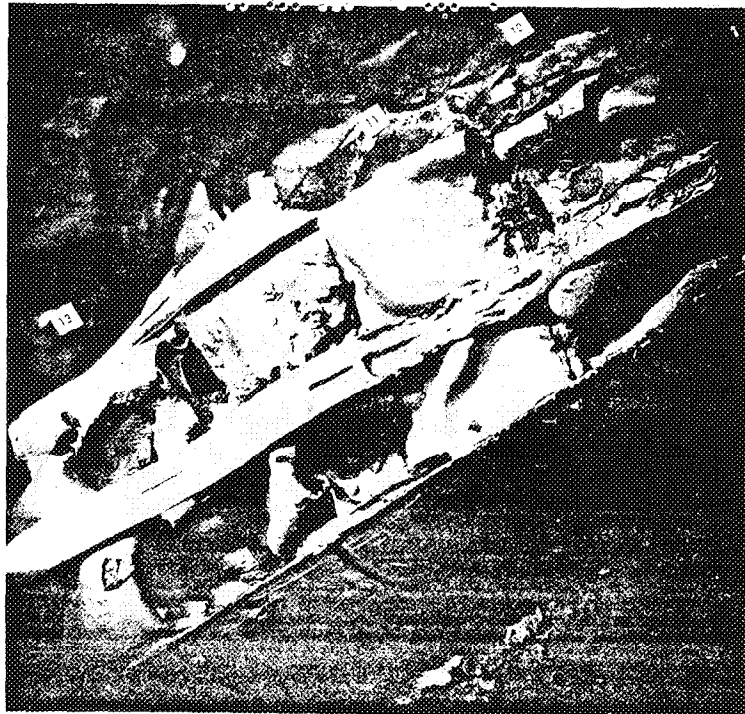
Inspection of the fuel cartridges that were removed from the moderator cells shows that melting and collapsing of the fuel elements was confined to stages 4 through 16. Fuel cartridge SN 1060 was removed from cell 273, which is in the outside circle of moderator cells. These cells produce about 7 percent less than the average total tube power and are representative of the lowest-power cells. The radial orientation (in degrees) indicated on the photographs is clockwise rotation from the "0" point (vertical centerline), looking downstream through the cartridge. Figure 76 shows the over-all fuel cartridge damage. The meltdown and chemical oxidation damage to stages 4, 5, and 6 of the fuel cartridge is clearly shown in Figure 77. The almost complete meltdown and oxidation of stage 5 is shown in Figure 78. Meltdown damage to stages 7, 8, and 9 is shown in Figure 79. Damage to stages 10 through 16 is shown in Figures 80 and 81. The meltdown

Fig. 80 – Damage to stages 10, 11, 12, and 13, cartridge 1060, cell 273

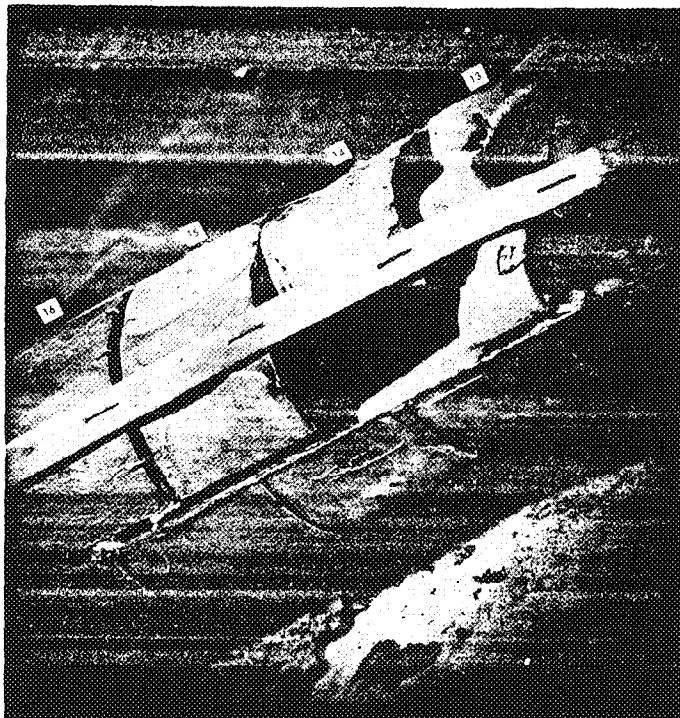
Fig. 81 – Damage to stages 13, 14, 15, and 16, cartridge 1060, cell 273

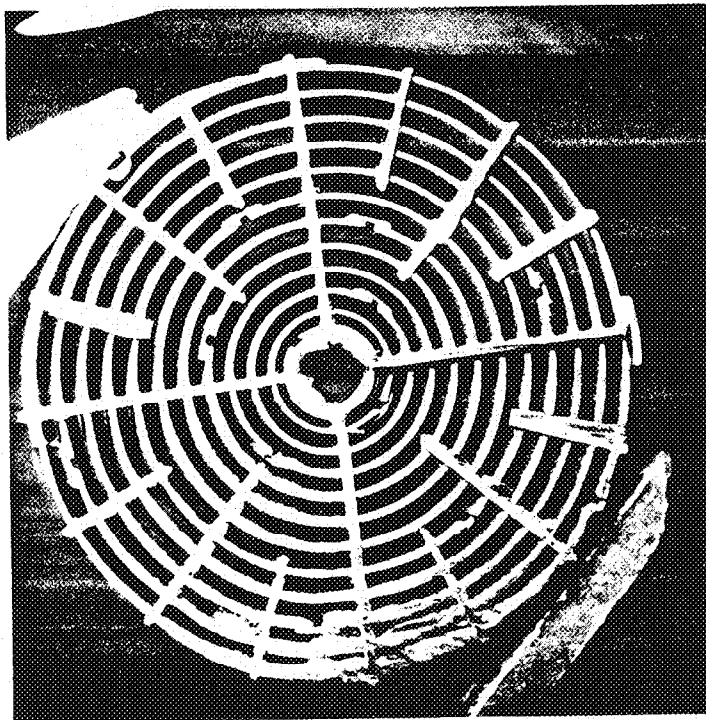
of stage 12 is shown in Figure 82. The 19th stage, which did not reach a temperature level as high as stages 4 through 16, is shown in Figures 83 and 84 to have sustained relatively little damage.

Fig. 83 — Upstream face of stage 19, cartridge 1060, cell 273

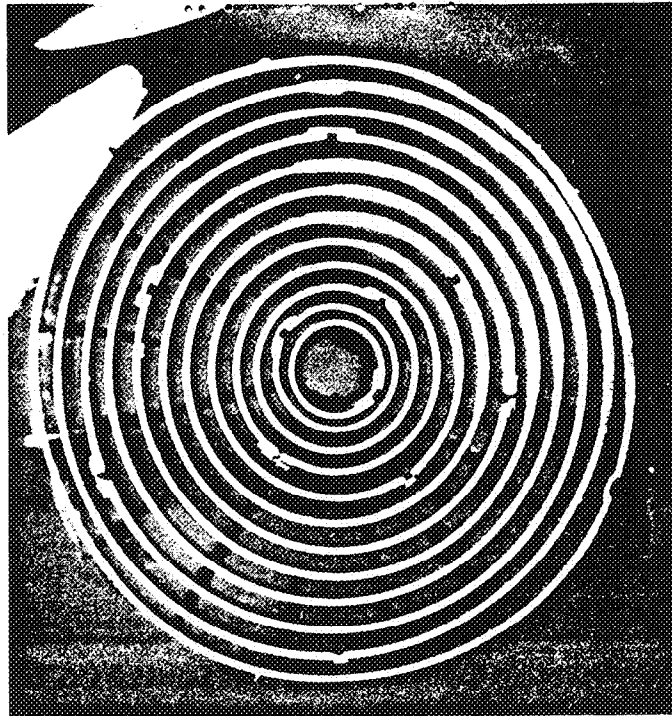
Fig. 84 — Downstream face of stage 19, cartridge 1060, cell 273

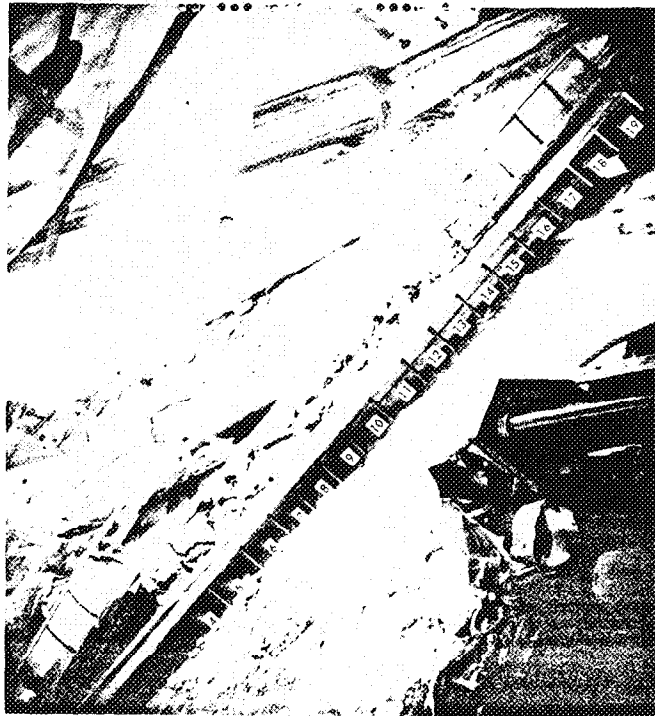
Another example of cartridge damage was obtained from cell 510, which is located in the innermost circle of moderator cells. These cells produce 7 percent above average total tube power and are representative of the highest-power cells. The total damage to this fuel cartridge is shown in Figure 88. Stages 1, 2, and 3, shown in Figure 89, appear to have sustained little or no damage. Figure 90 shows the meltdown and chemical oxidation damage in stages 4, 5, and 6. Figures 91, 92, and 93 show the damage that occurred to stages 7 through 15. The meltdown and possible chemical oxidation damage appear to be greater than the damage to the same stages in Cell 273 (Figures 79, 80, and 81). The The damage sustained in stages 16 through 19 is shown in Figures 94 and 95.

Fig. 88 – Overall damage to fuel cartridge 1129, cell 510

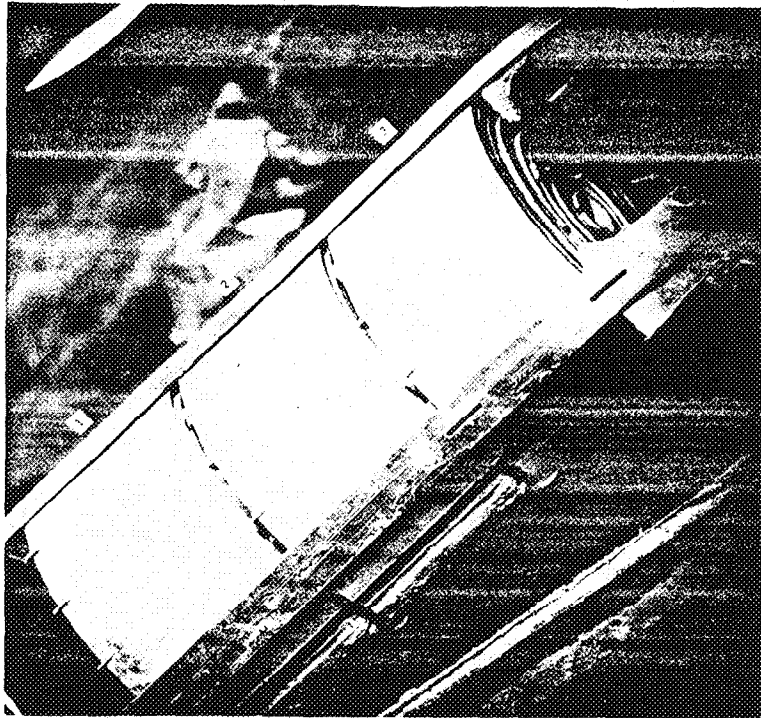
Fig. 89 – Stages 1, 2, and 3, cartridge 1129, cell 510

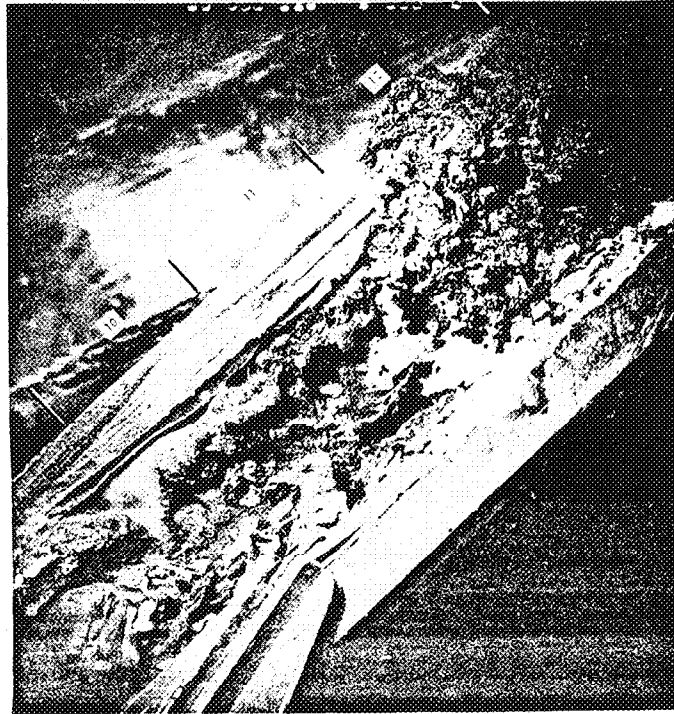
Fig. 92 — Stages 10, 11, and 12, cartridge 1129, cell 510

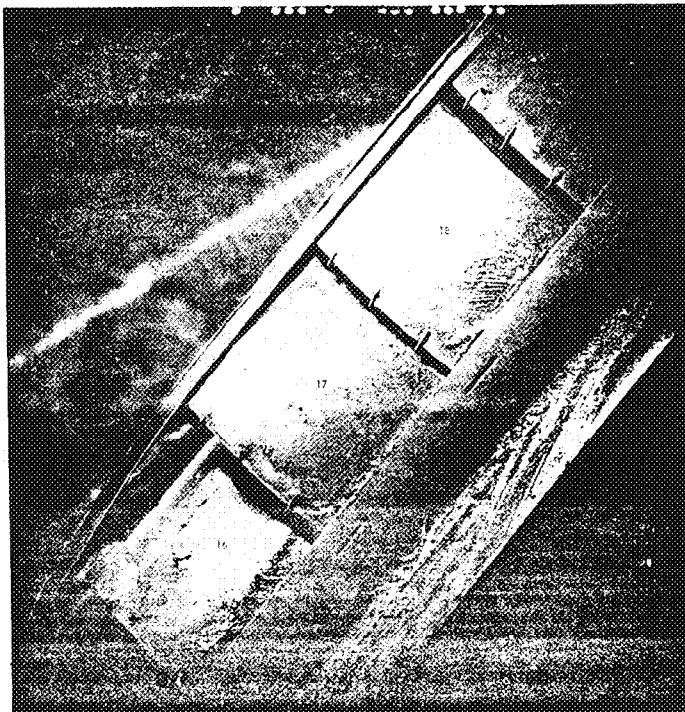
Fig. 94 – Stages 16, 17, and 18, cartridge 1127, cell 510

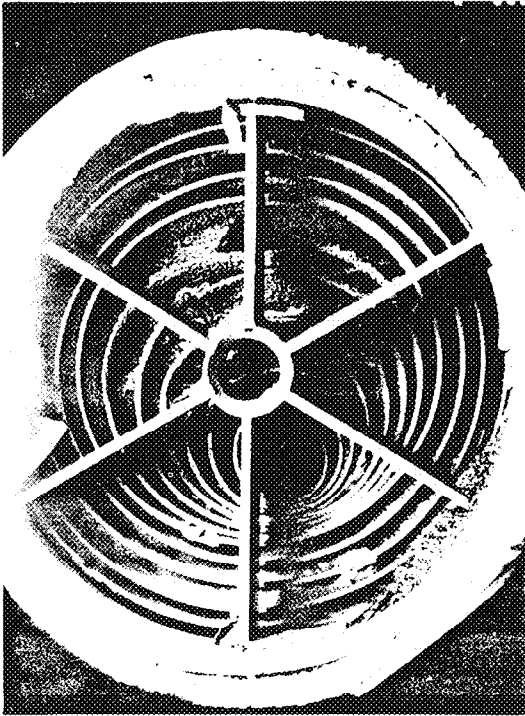
Fig. 96 — Typical ring deformation at 19th stage, downstream face

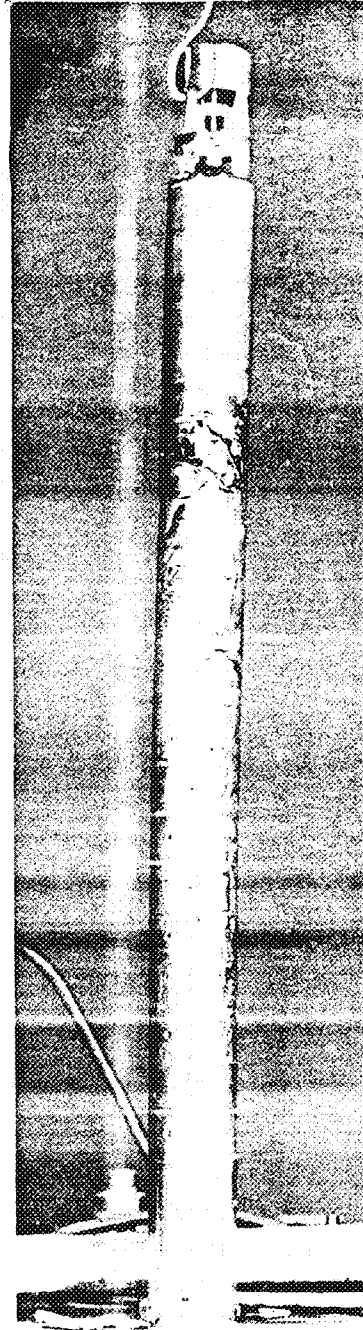
Fig. 97 — Example of burning, wrinkling, and bowing of fuel cartridges and liners

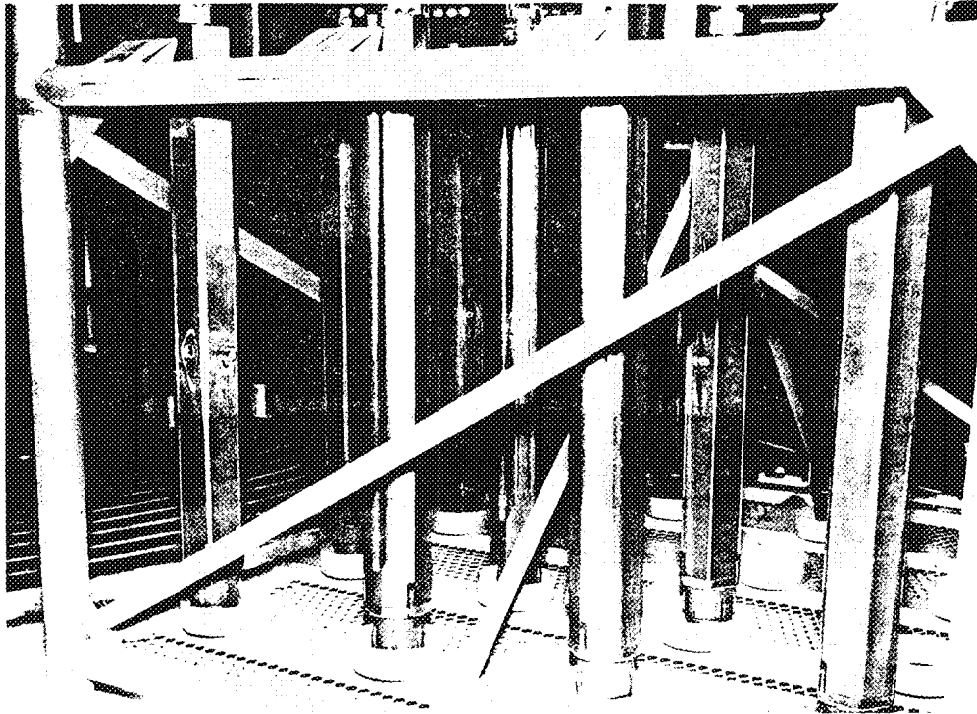
Fig. 99 – Moderators in storage rack showing burn spots

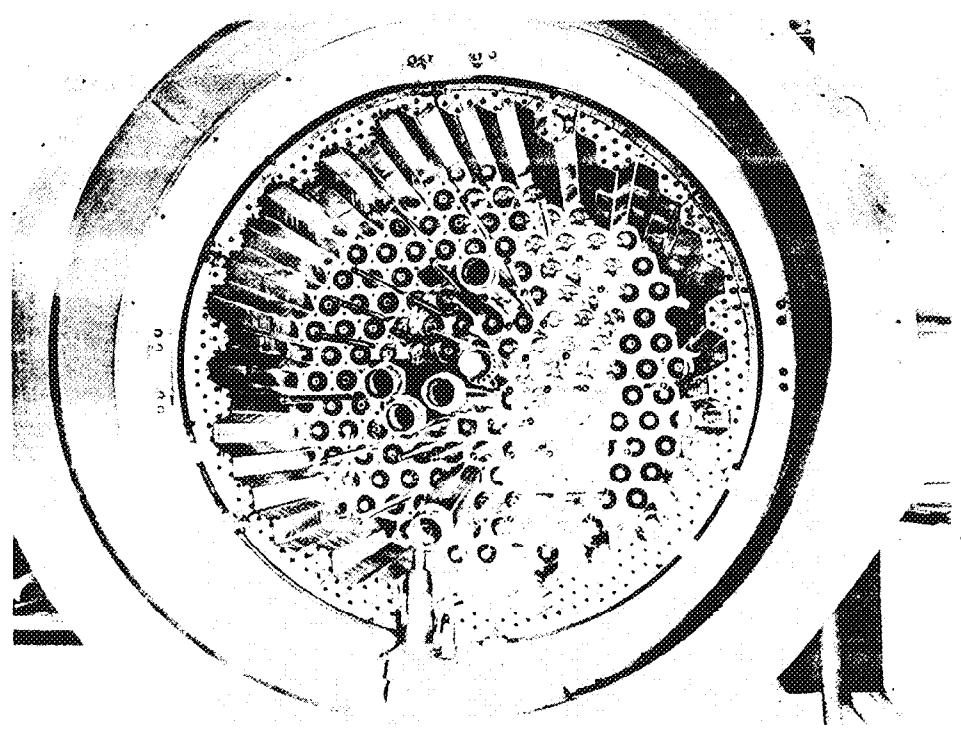
Fig. 101 – Cross section of moderator showing melting and burning damage

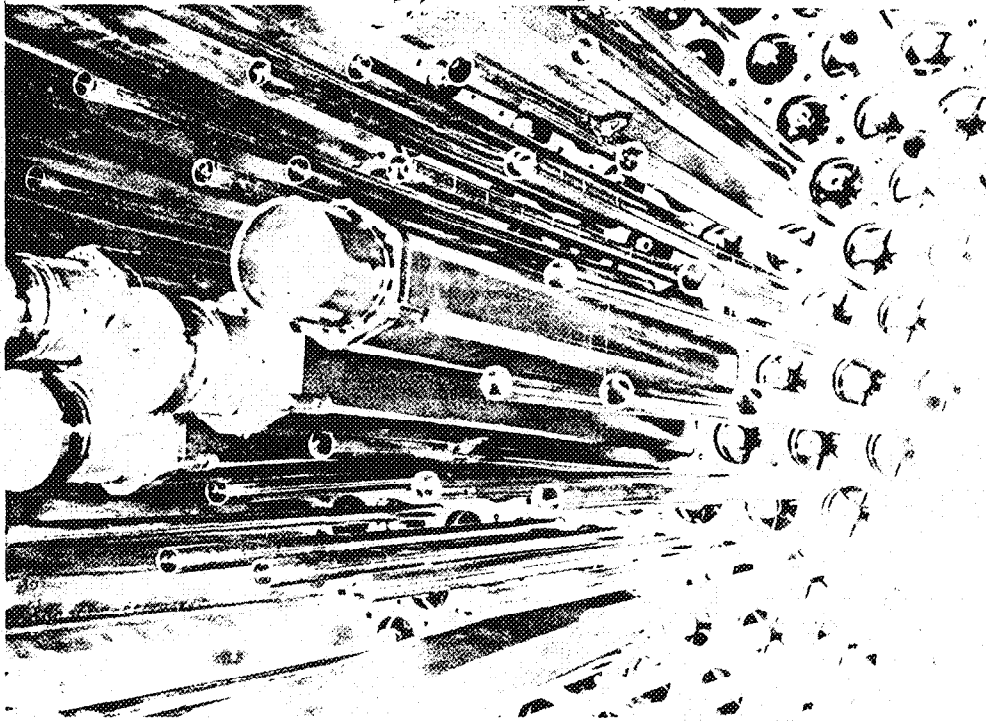
Many of the hydrided zirconium hexagonal moderator blocks were intact and will be reusable. In a few isolated cases molten slag had burned through the moderator block and welded the moderator block to the adjacent control rod guide tubes. A typical moderator block with melt-through is shown in section 5.1, Figure 101. It has been determined that 74 moderator blocks will be reusable. The control rod guide tubes, in general, will be reusable after replating.

Fig. 102 – Reactor core showing five moderator blocks welded to control rod guide tubes, View A

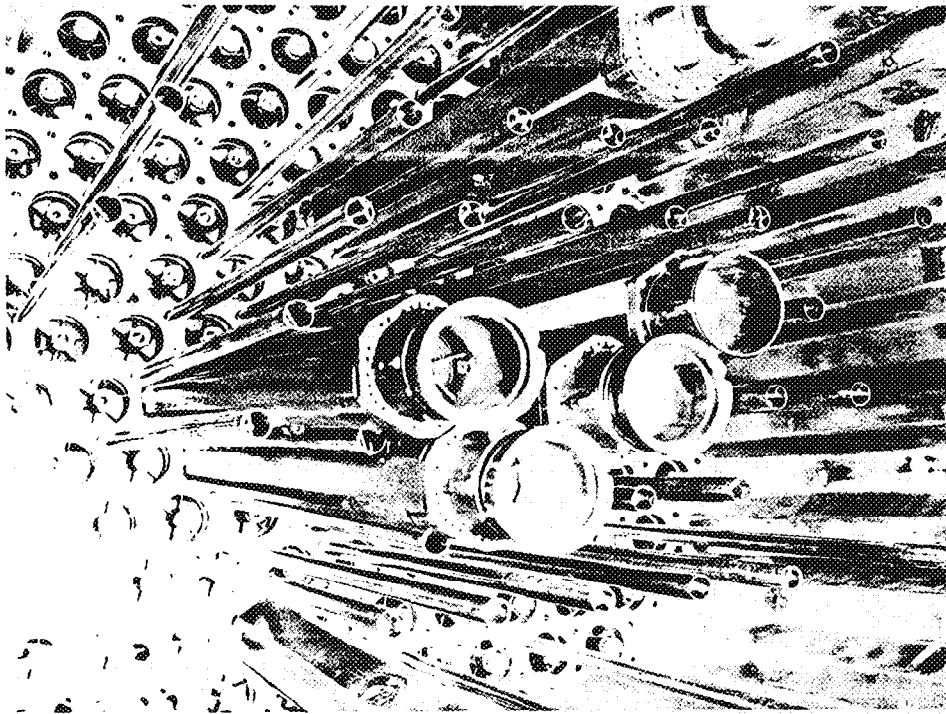
Fig. 104 — Reactor core showing five moderator blocks welded to control rod guide tubes, View C

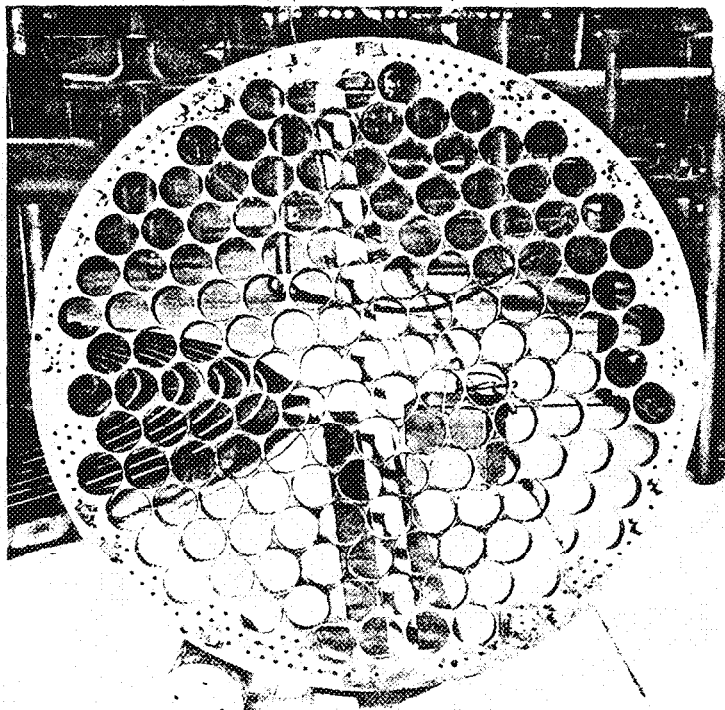
No visible damage that can be attributed to the incident was noted on the front and rear tube sheets or reflector. Only normal heat discoloration on the inside walls of the reflector and on the rear tube sheet was evident (see Figure 106). Some damage occurred to the instrumentation on the front tube sheet during disassembly and will require shop rework.

Fig. 106 — Rear tube sheet, upstream face

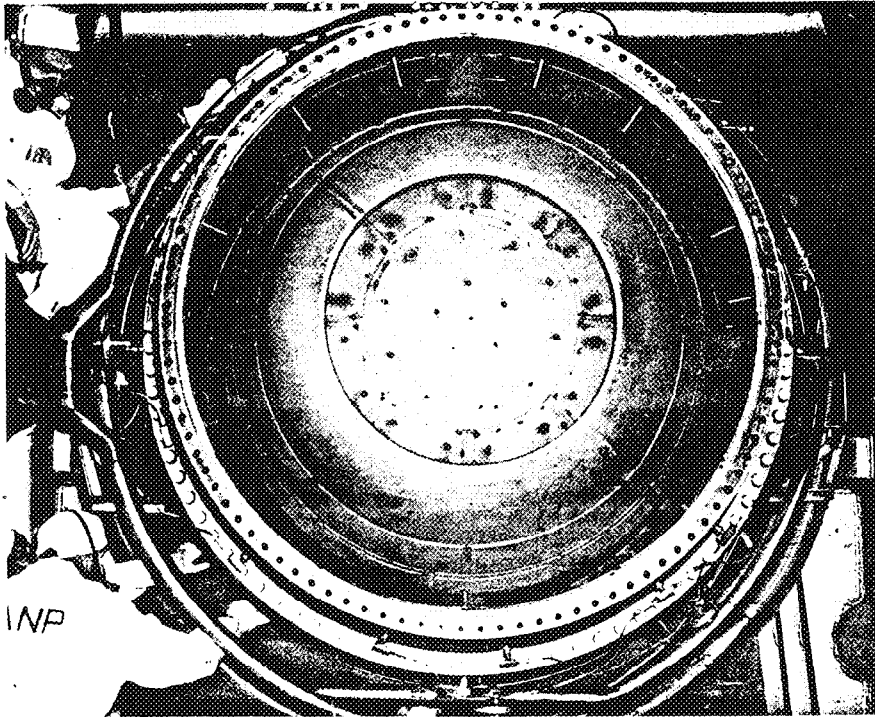
No visible damage was sustained during the event by the front and rear plug shields, primary shield, combustor, and aft header. Figure 107 shows the aft face of the front

Fig. 107 — Aft face of front plug shield

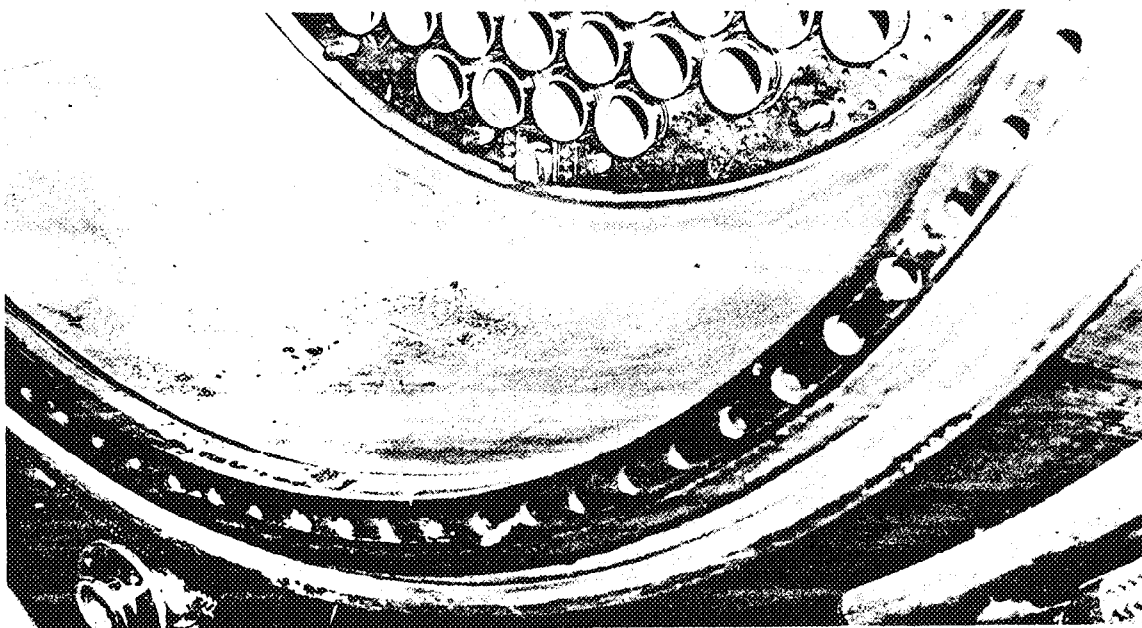
Fig. 109 – Deposits at bottom of primary shield
